Erosion Assessment for Montezuma Castle and Tuzigoot National Monuments

Natural Resource Technical Report NPS/SODN/NRTR—2010/281

January 2010

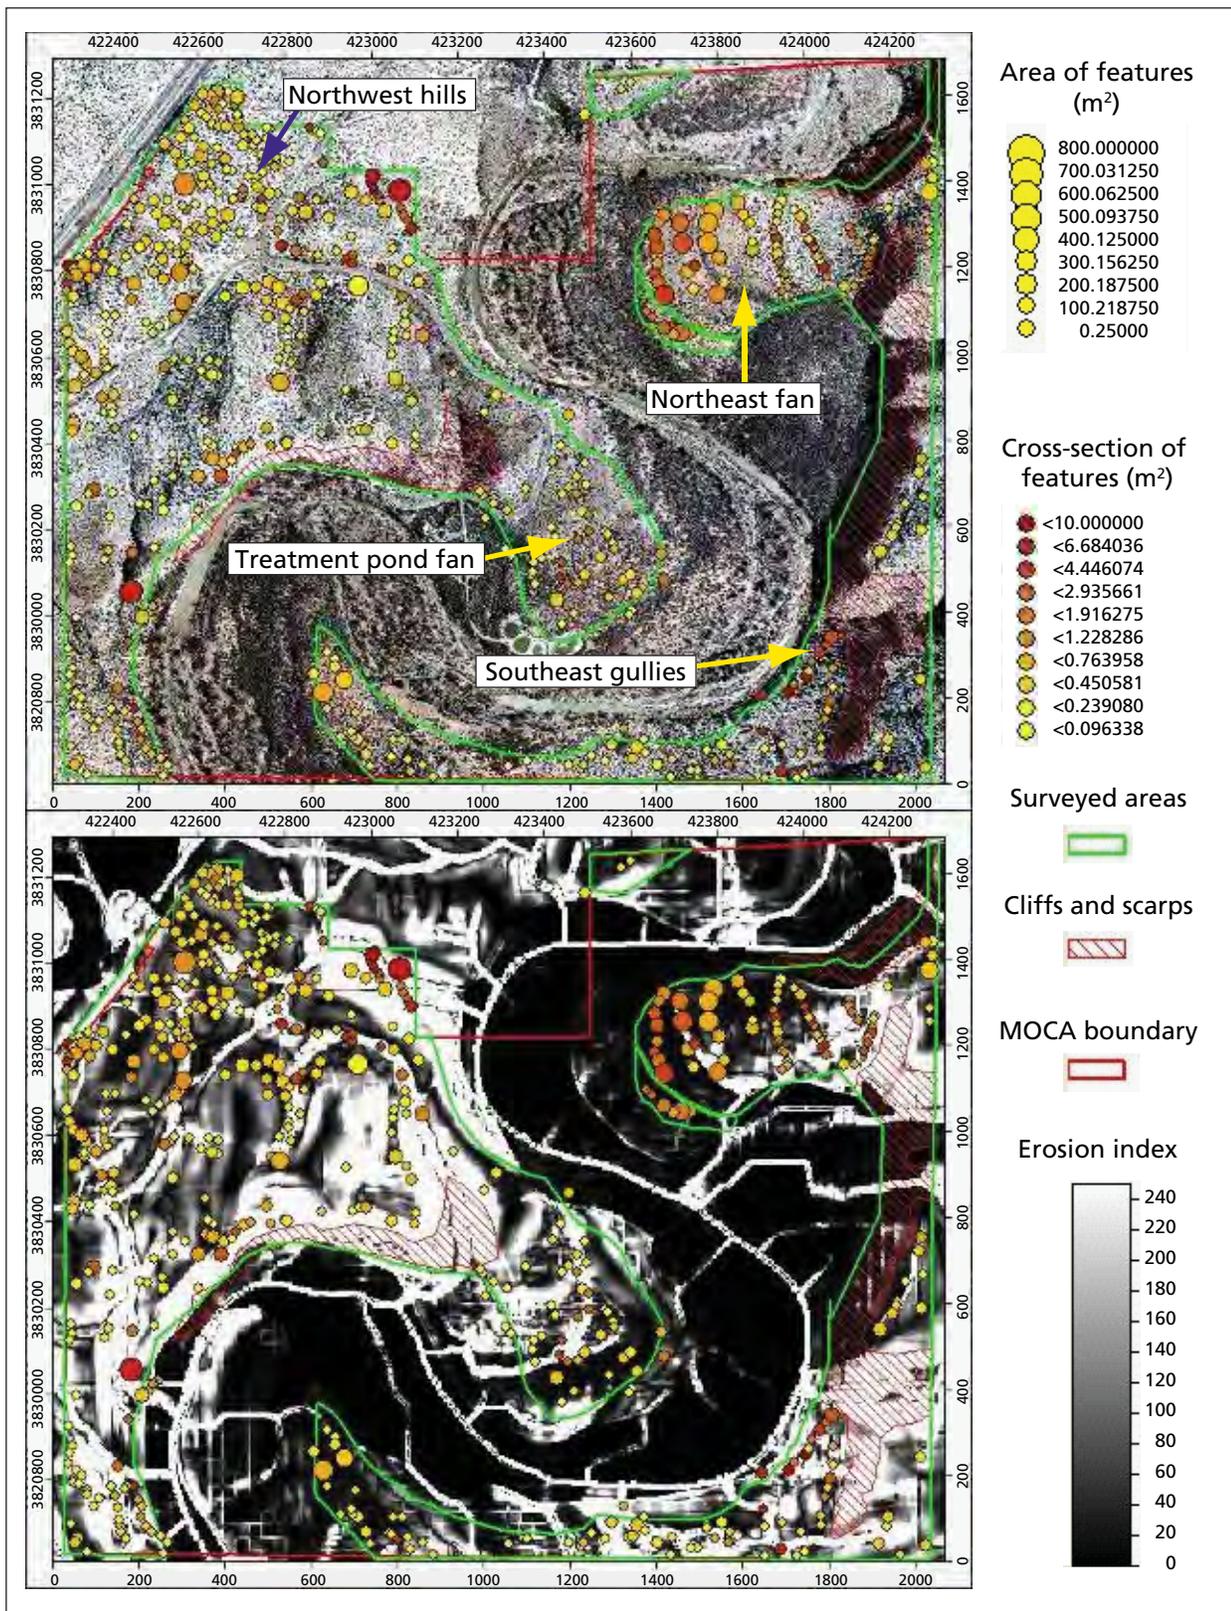
From the points taken, unique features were identified by combining points with the same feature ID. These unique features included 225 areas of sheet erosion, 165 rills, and 96 gullies. Total estimated soil loss from mapped features was 10,951 m³. Estimated contribution from different feature types included 1,584 m³ from sheet areas, 810 m³ from rills, and 8,557 m³ from gullies. See Figure 3.1 for a complete map of features.

Figure 3.1. Maps showing erosion observations draped over 0.48-meter-resolution aerial photography (top) and a USPED erosion index (bottom). Redder dots have a deeper and wider soil-loss profile. Larger dots correspond to larger areas covered by erosion features. Lighter erosion-index colors indicate higher potential for either erosion or deposition and, thus, represent areas where surface-erosion features were expected in the field. Side ticks on left and top are UTM coordinates in meters. Ticks at bottom and right are scale bars in meters.

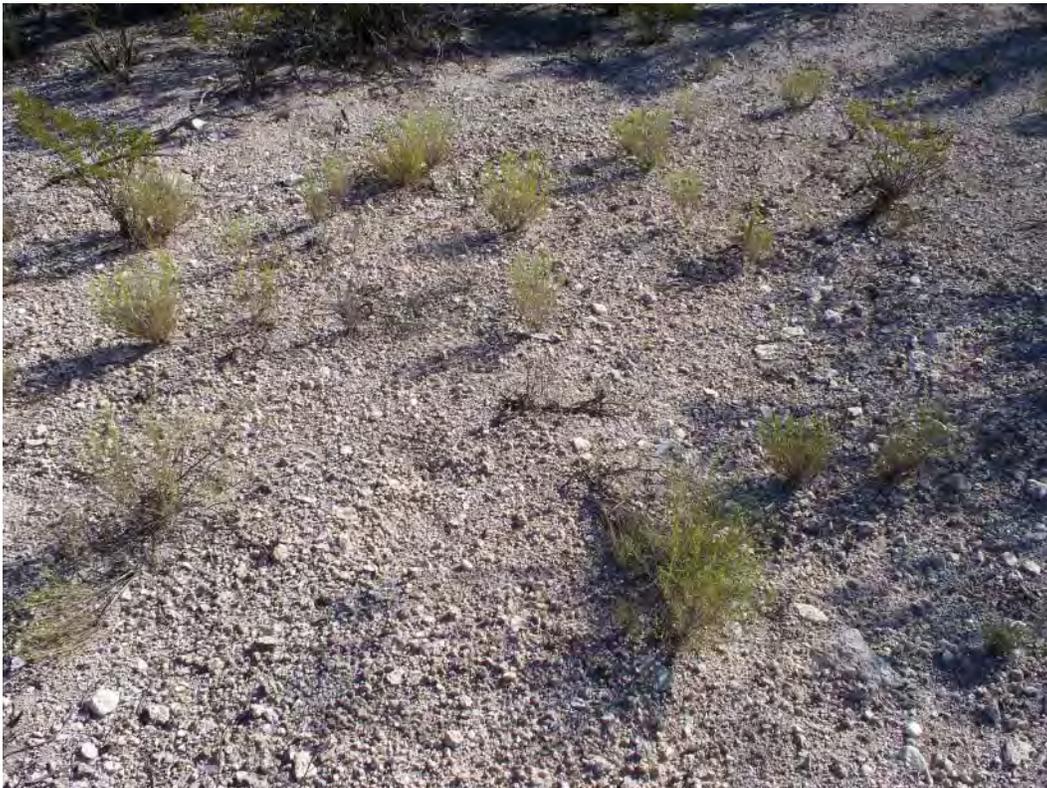
Limestone hills in the northwestern part of the monument show dense numbers of small to mid-sized rill and sheet-erosion features (Figure 3.1.2). Gullies in some of the small drainages associated with these hills probably resulted from high-energy runoff and erosion on adjacent hillslopes.

Figure 3.1.2. Area of sheet erosion with slightly pedestalled sparse vegetation, located on a slope in the northwestern part of MOCC.

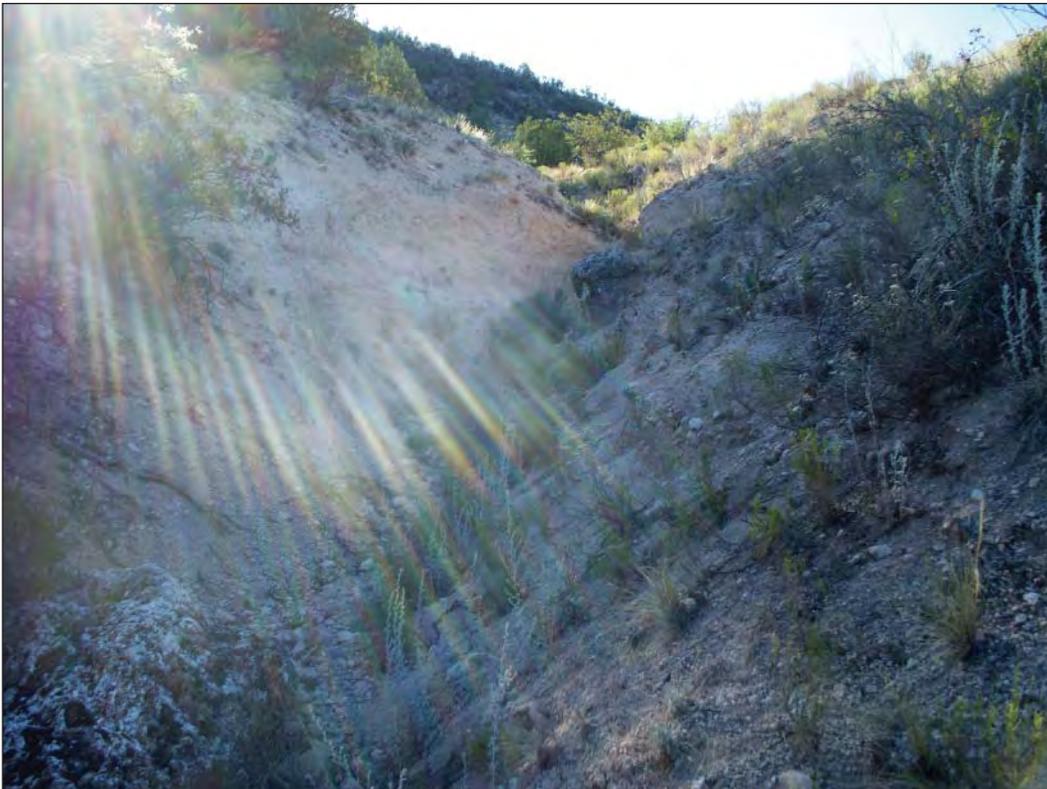
Slopes coming off the highlands in the extreme southeastern part of MOCC showed susceptibility to gully cuts. A series of gullies and associated rilled sideslopes were observed roughly every 30–40 meters along a traverse of the backslope (Figure 3.1.3).

Figure 3.1.3. Gully cutting into slope above Beaver Creek, southeast corner of MOCC.

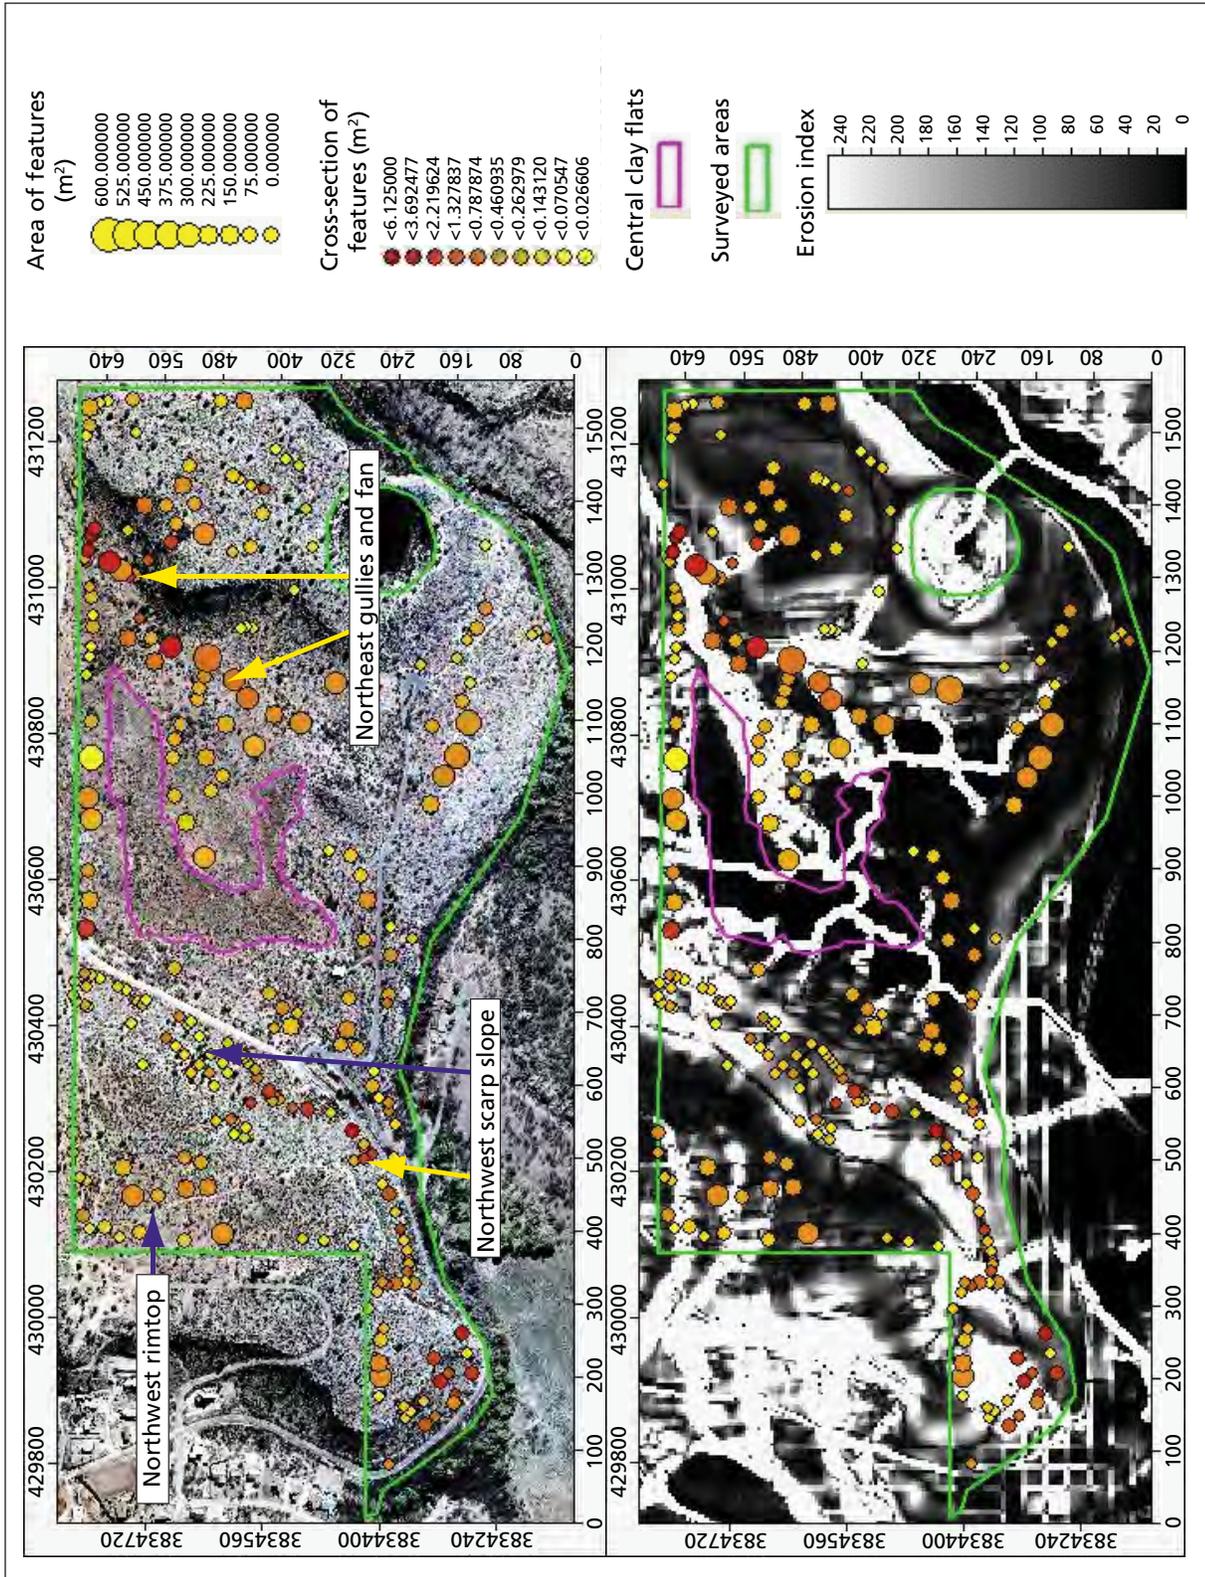
timated soil loss from mapped features was 2,071 m³. Estimated contribution from different feature types included 549 m³ from sheet areas, 386 m³ from rills, and 1,136 m³ from gullies. See Figure 3.2 for a complete depiction of mapped erosion features in MOWE.

Figure 3.2. Maps showing erosion observations draped over 0.4-meter-resolution aerial photography (top) and a USPED erosion index (bottom). Redder dots have a deeper, wider soil loss profile. Bigger dots represent larger areas covered by erosion features. Lighter erosion-index colors indicate higher potential for either erosion or deposition and, thus, areas where surface-erosion features were expected in the field. Side ticks on left and top are UTM coordinates in meters. Ticks at bottom and right are scale bars in meters.

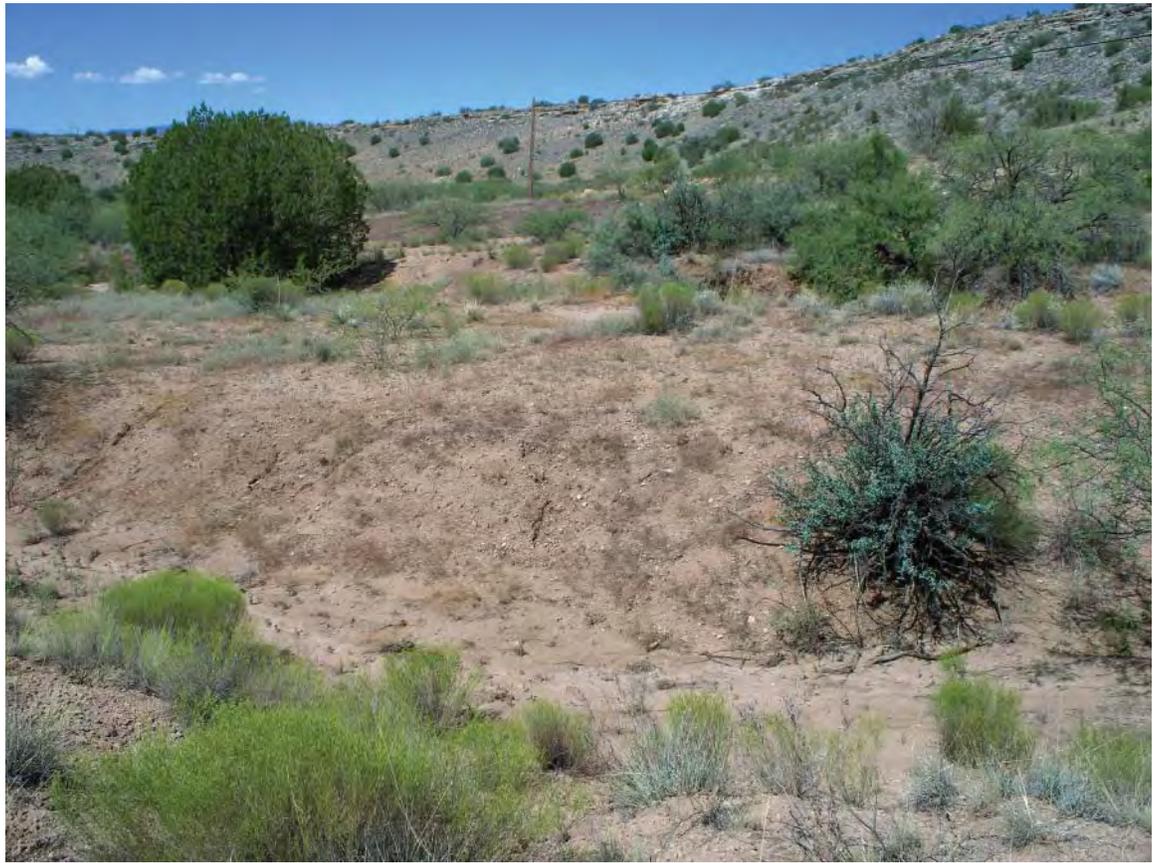
A series of gullies has cut through the northeast part of the park just below the Beaver Creek Road. Some are not downcutting as sharply as they may have in the past, but do appear to be widening (Figure 3.2.2). Also, some side gullies and rills have begun to form from the central gully channels.

Because gully cuts tend to move upstream, these gullies probably will not extend down into other parts of the monument, but still may change the hydrology of the area. The small size of the watershed above these cuts will probably not encourage upstream growth, either, but the side branches off the main gully could continue to erode and effectively lower the overall base level of the draw in this area, resulting in large movements of sediment downstream.

Figure 3.2.2. This gully, in the northeast corner of MOWE, has begun to widen since its initial downcutting.

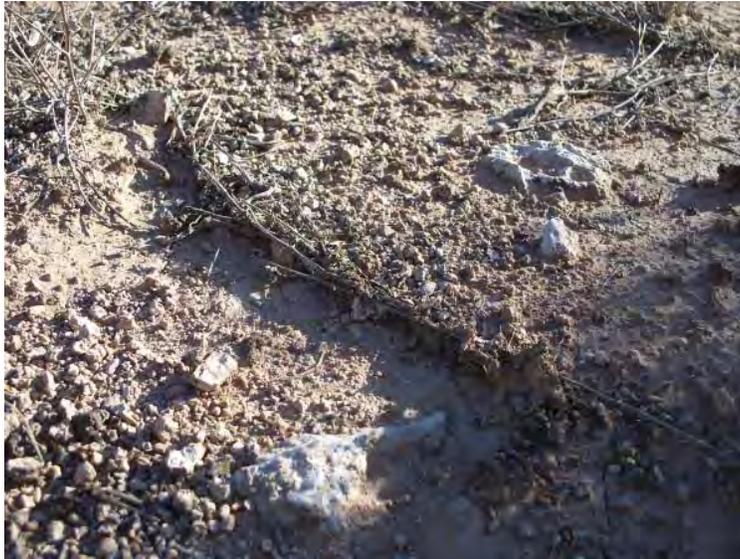
This area is characterized by slightly accelerated sheet and rill erosion in some spots and stabilization by vegetation, litter, and biological soil crust in others. Due to large plant interspaces and relatively fine-grained surface soils, these areas

erode easily if surface crusts or litter covers are disturbed. Many rimtop areas showed signs of sheet flow slowed by small litter/soil-crust dams that keep levels of both flow energy and sediment transport relatively low (Figure 3.2.3). These areas are so close to becoming erosional that even a couple of people walking through them could disturb the dams and crust enough to allow the next flow event to start displacing surface soil. This situation appears to have already occurred in the extreme northwest corner of the park, where some of the rills and sheet erosion are collocated with a trail evident on the aerial imagery and observed during field efforts.

Figure 3.2.3. This small dam of litter and soil crust is helping to prevent sheet flow from gaining too much energy on the northwest rim of MOWE.

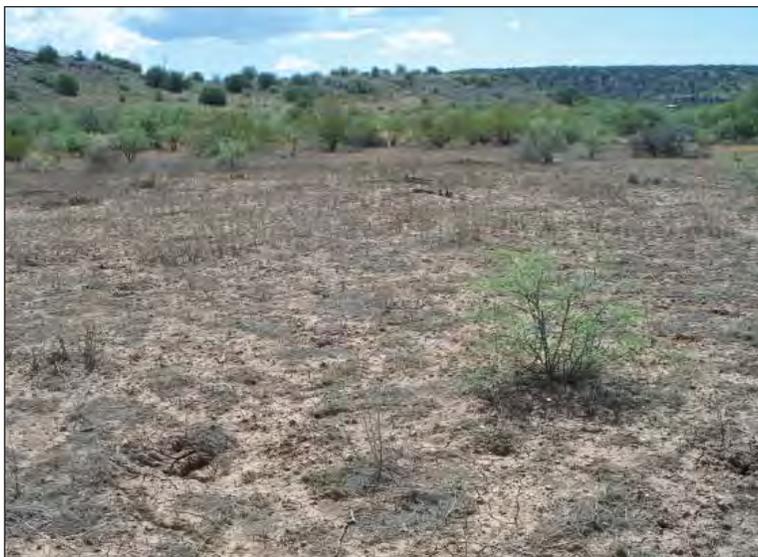
Located just south of Beaver Creek Road, after it turns east, are some relatively flat areas with clayey soils that exhibit high shrink–swell activity during dry–wet cycles (Figure 3.2.4). That activity leaves cracks and depressions in the landscape that help to slow surface flow, but also make it difficult for vegetation to establish. This area’s lime-rich geology also means that its soils are high in calcium

carbonate and other more soluble minerals. Dissolution is likely occurring along the subsurface cracks, and probably playing a role in creating the depressions, through a process called subsidence. This subsidence, and the extensive animal burrowing observed in these areas, are two factors generally associated with shrink-swell soils and the probable loss of soil minerals dissolved by subsurface water flow. The shrink-swell activ-

ity associated with precipitation events makes it difficult to gauge the amount of surface erosion occurring. However, lack of continuous flow patterns in interplant areas, and well-structured, high-activity clays (i.e., very sticky and probably well-flocculated due to high Ca^{2+} concentration) suggest that not much soil is moving via water or wind erosion in these areas (see pink polygon in Figure 3.2).

Figure 3.2.4. Area of high-activity clay in central part of park. Only certain grasses and mesquite are lightly established on this soil type, with large areas of bare ground exposed. The cracking and associated macropores and burrows in this soil cause pedestalling around plants and patterns of depressions that help to slow surface flow.

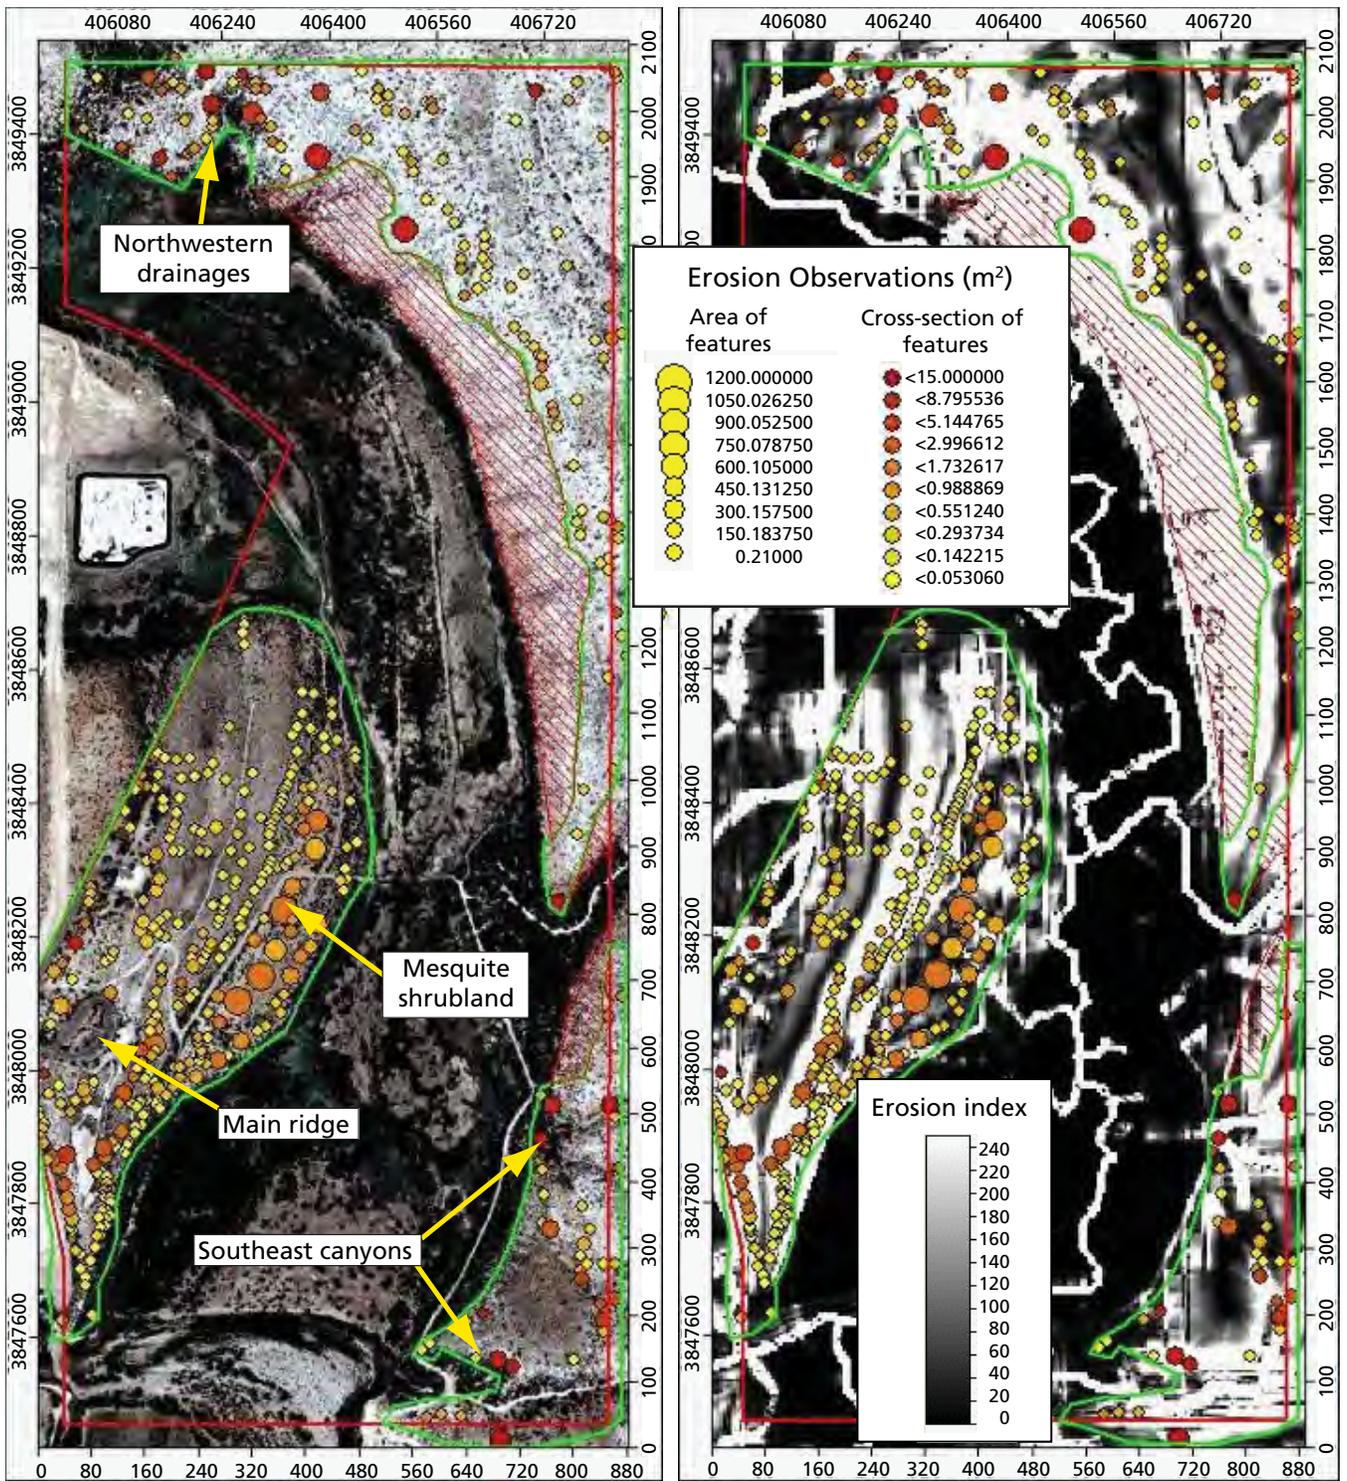
From the points taken, unique features were identified by combining points with the same feature ID. These unique features included 118 areas of sheet erosion, 250 rills, and 50 gullies. Total estimated soil loss from mapped features was 10,274 m³. Estimated contribution from different feature types included 889 m³ from sheet areas, 3,426 m³ from rills, and 5,959 m³ from gullies. See Figure 3.3 for a complete map of mapped features.

Figure 3.3. Maps showing erosion observations draped over 1-meter-resolution aerial photography (left) and a USPED erosion index (right). Lighter erosion-index values indicate higher potential for either erosion or deposition and, thus, areas where surface-erosion features were expected in the field. Green polygons show areas surveyed. The red polygon is the TUZI legal boundary. The red diagonal fill pattern represents upland areas that were not directly surveyed due to dangerous terrain. Side ticks on left and top are UTM coordinates in meters. Ticks at bottom and right are scale bars in meters. The white meandering lines of the USPED index in the middle of the map should be ignored; they are an artifact of a flow-forcing portion of the algorithm that has problems in areas that are flat or in depressions.

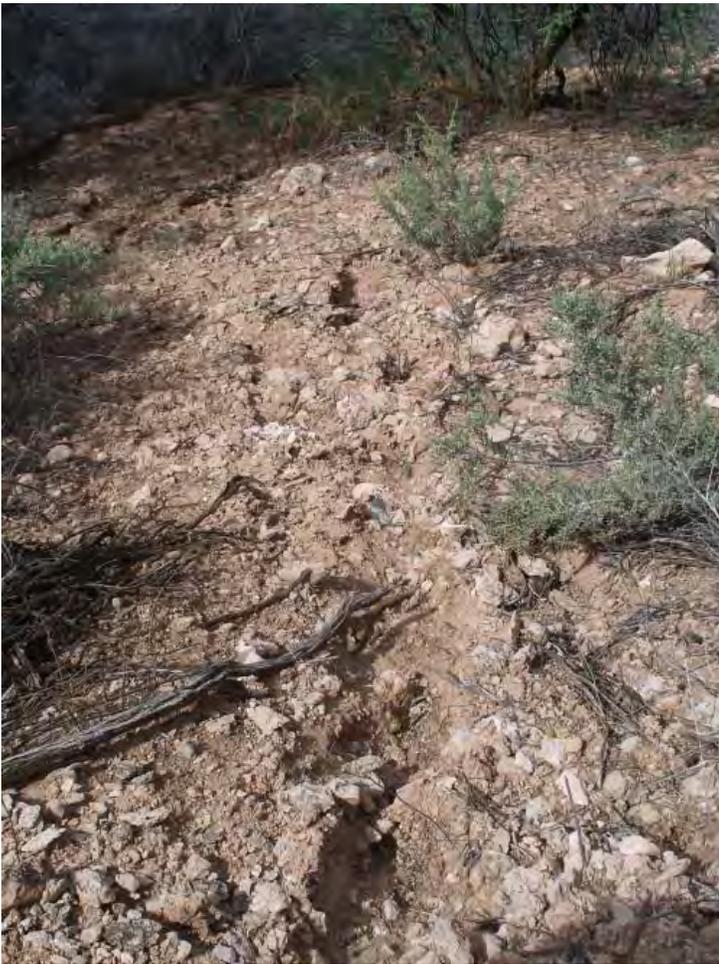
This area includes the monument's primary attraction, where ruins are located along a ridgetop. Both the western and eastern slopes of the southern three-quarters of the main ridge exhibited extensive rilling and sheet erosion (Figure 3.3.1). Areas on the steep slopes on either side of the main pueblo showed some of the most prolific rilling in the monument, along with general hill-slope instability.

Figure 3.3.1. Rilling on southwest side of the main ridge.

Erosion levels in these areas were surprising, given the rocky character of the slopes and presence of the park road, which might be expected to block or at least slow runoff from the mesquite shrubland. Under current conditions, it is possible that the slopes could eventually undercut sidewalks and infrastructure, especially below the ridgetop walkways. This is a particular concern given the number of cultural artifacts concentrated in this area. Some of the steep slopes in this area are off-limits to visitors; keeping that rule in place will benefit both visitor safety and the area's natural and cultural resources. In addition, regular inspection of slopes, from the walkways, may be warranted after storm events.

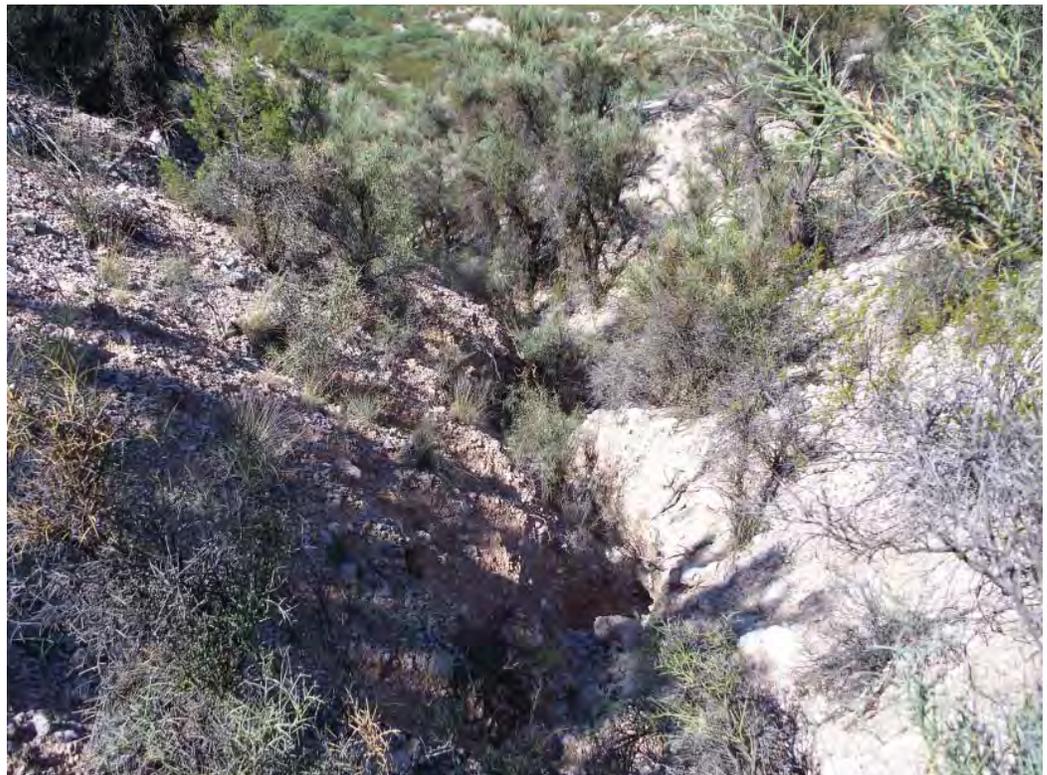
Washes in the northwestern part of TUZI have cut into the higher upland areas and appear to have triggered large numbers of gully cuts and rilling of associated backslopes (e.g., Figure 3.3.3). In these areas, the well-defined cliffline, such as that found along the monument's eastern side, has eroded away to create topography and slopes more susceptible to soil loss. Weathering on the resulting hillsides has left finer materials exposed on the surface. These materials are highly erodible in the absence of vegetation to stabilize slopes.

Figure 3.3.3. Gully in the northwestern-drainages area, showing an unstable sideslope above the actual cut.

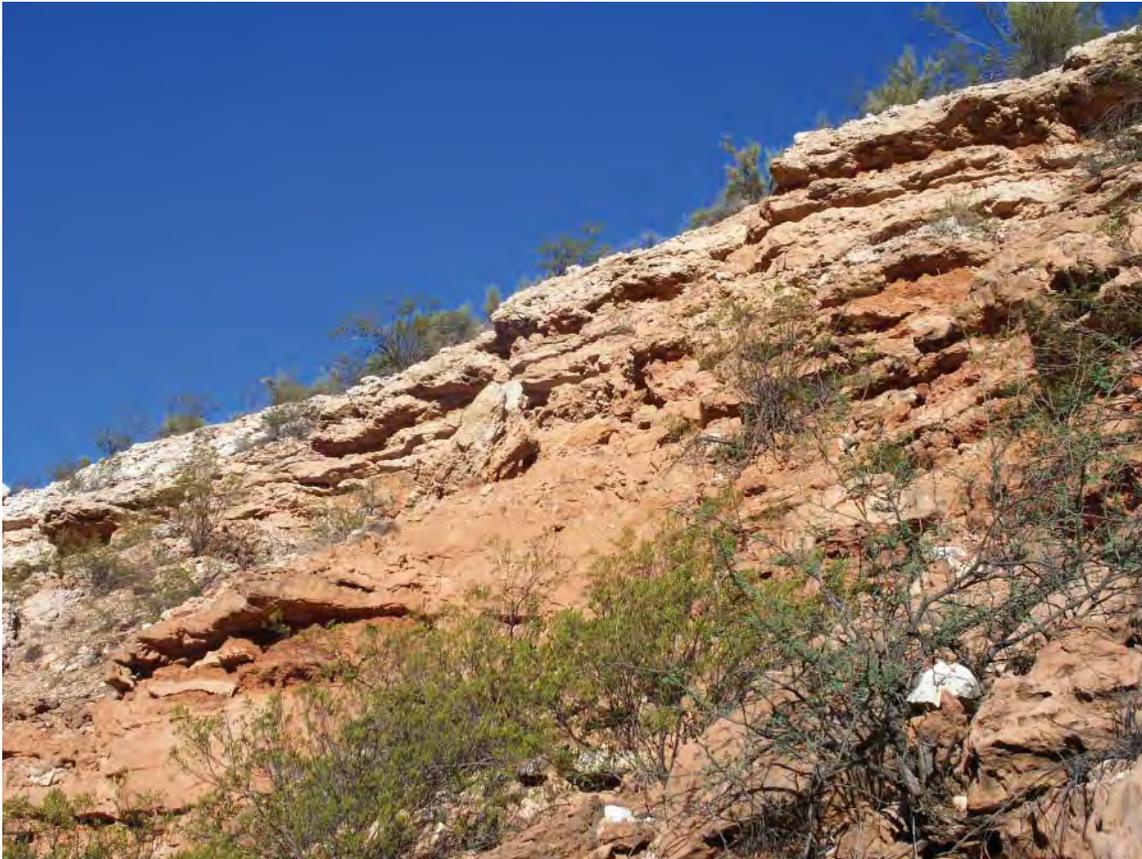
rim directly above these cliffs, a lack of small side-canyon cuts and gullying indicated limited acceleration of soil loss above natural rates. However, some large rock movements and rilling were observed in the red sandstone deposit beneath the limestone deposits along the scarp (Figure 3.3.5).

Figure 3.3.5. Limestone–Sandstone interface on scarp. This spot showed evidence of accelerated slope movement in the less-stable sandstone layer, where some large boulders have recently detached.
