# Estuarine Restoration

## LEWIS AND CLARK NATIONAL HISTORICAL PARK

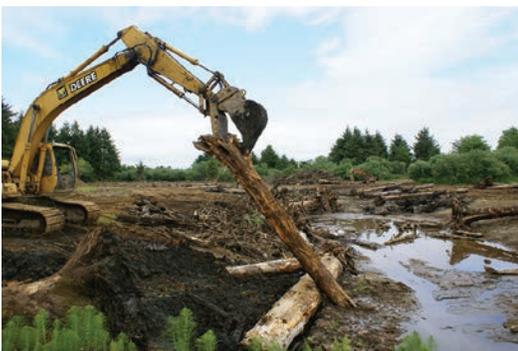
**Opposite Left** Large woody debris is placed into the newly excavated south channel. NPS/LEWI

Restoration crews set large woody debris and willows into the banks of the channel to increase habitat complexity, to provide cover for juvenile salmon,

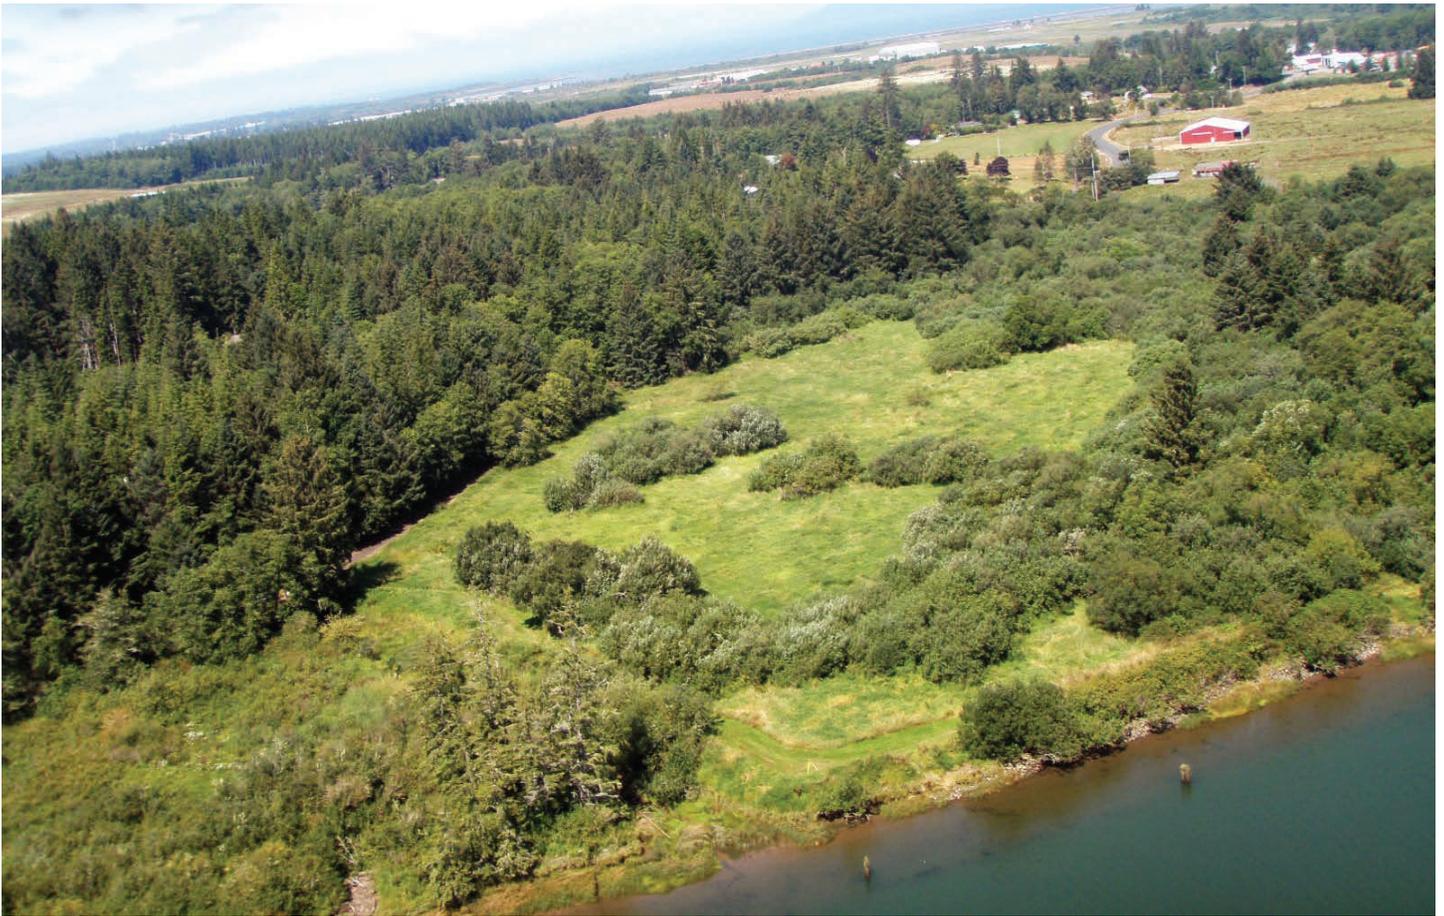
**Above** A former tidal wetland, Otter Point has been diked, drained, and filled over the past 100 years. Reed canary grass dominated the site before restoration. NPS/LEWI
