Fourteen Years of Springflow Data at Arches National Park

Natural Resource Report NPS/NCPN/NRR—2015/1018

September 2015

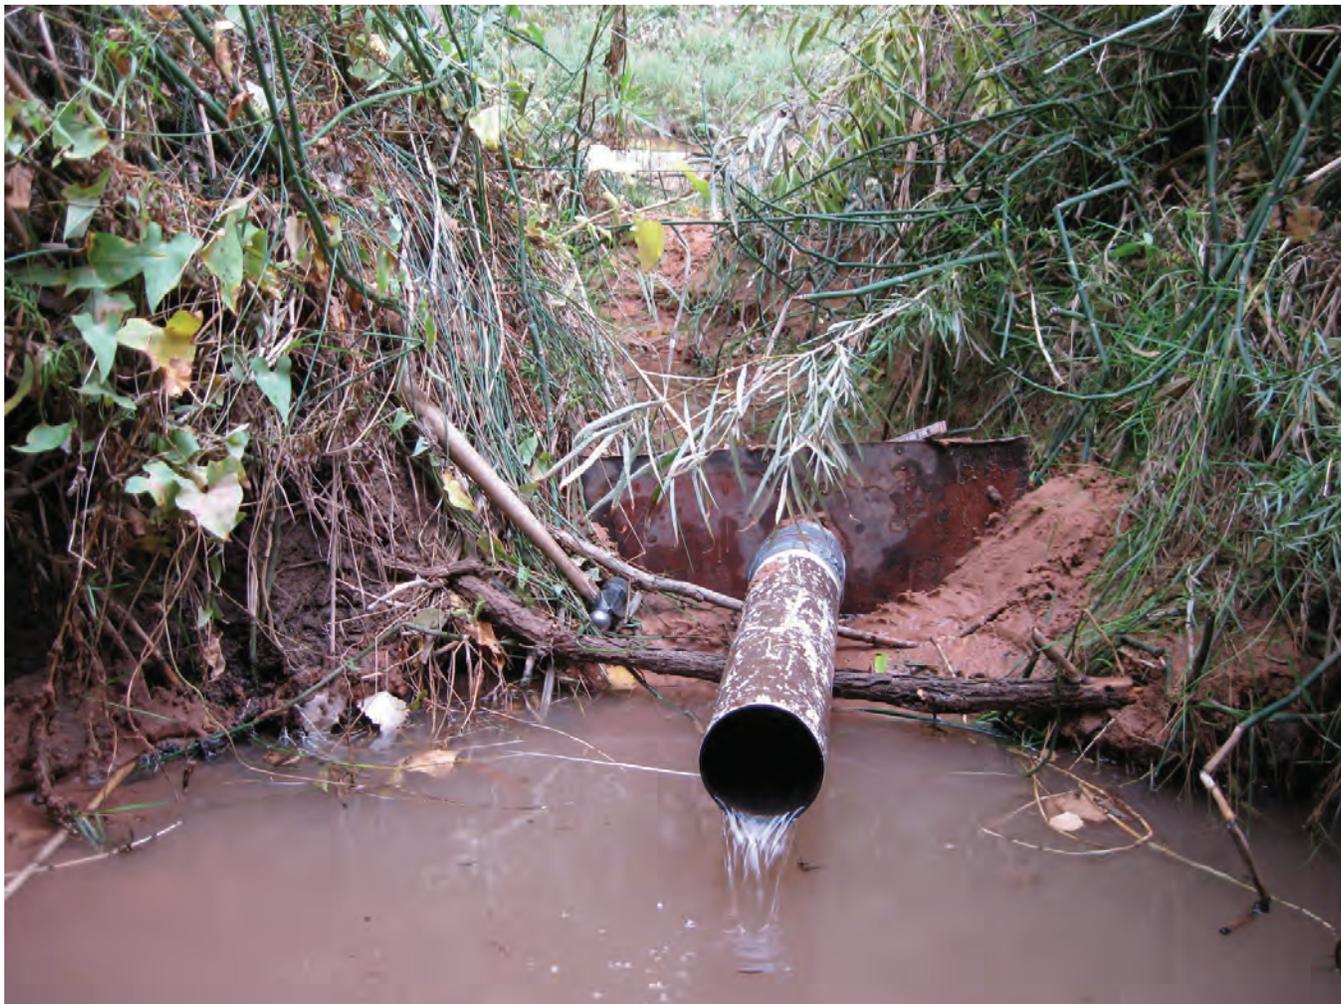
ON THE COVER

Temporary weir plate that enables flow measurements at Sleepy Hollow Spring, Arches National Park.
NPS/M. Moran

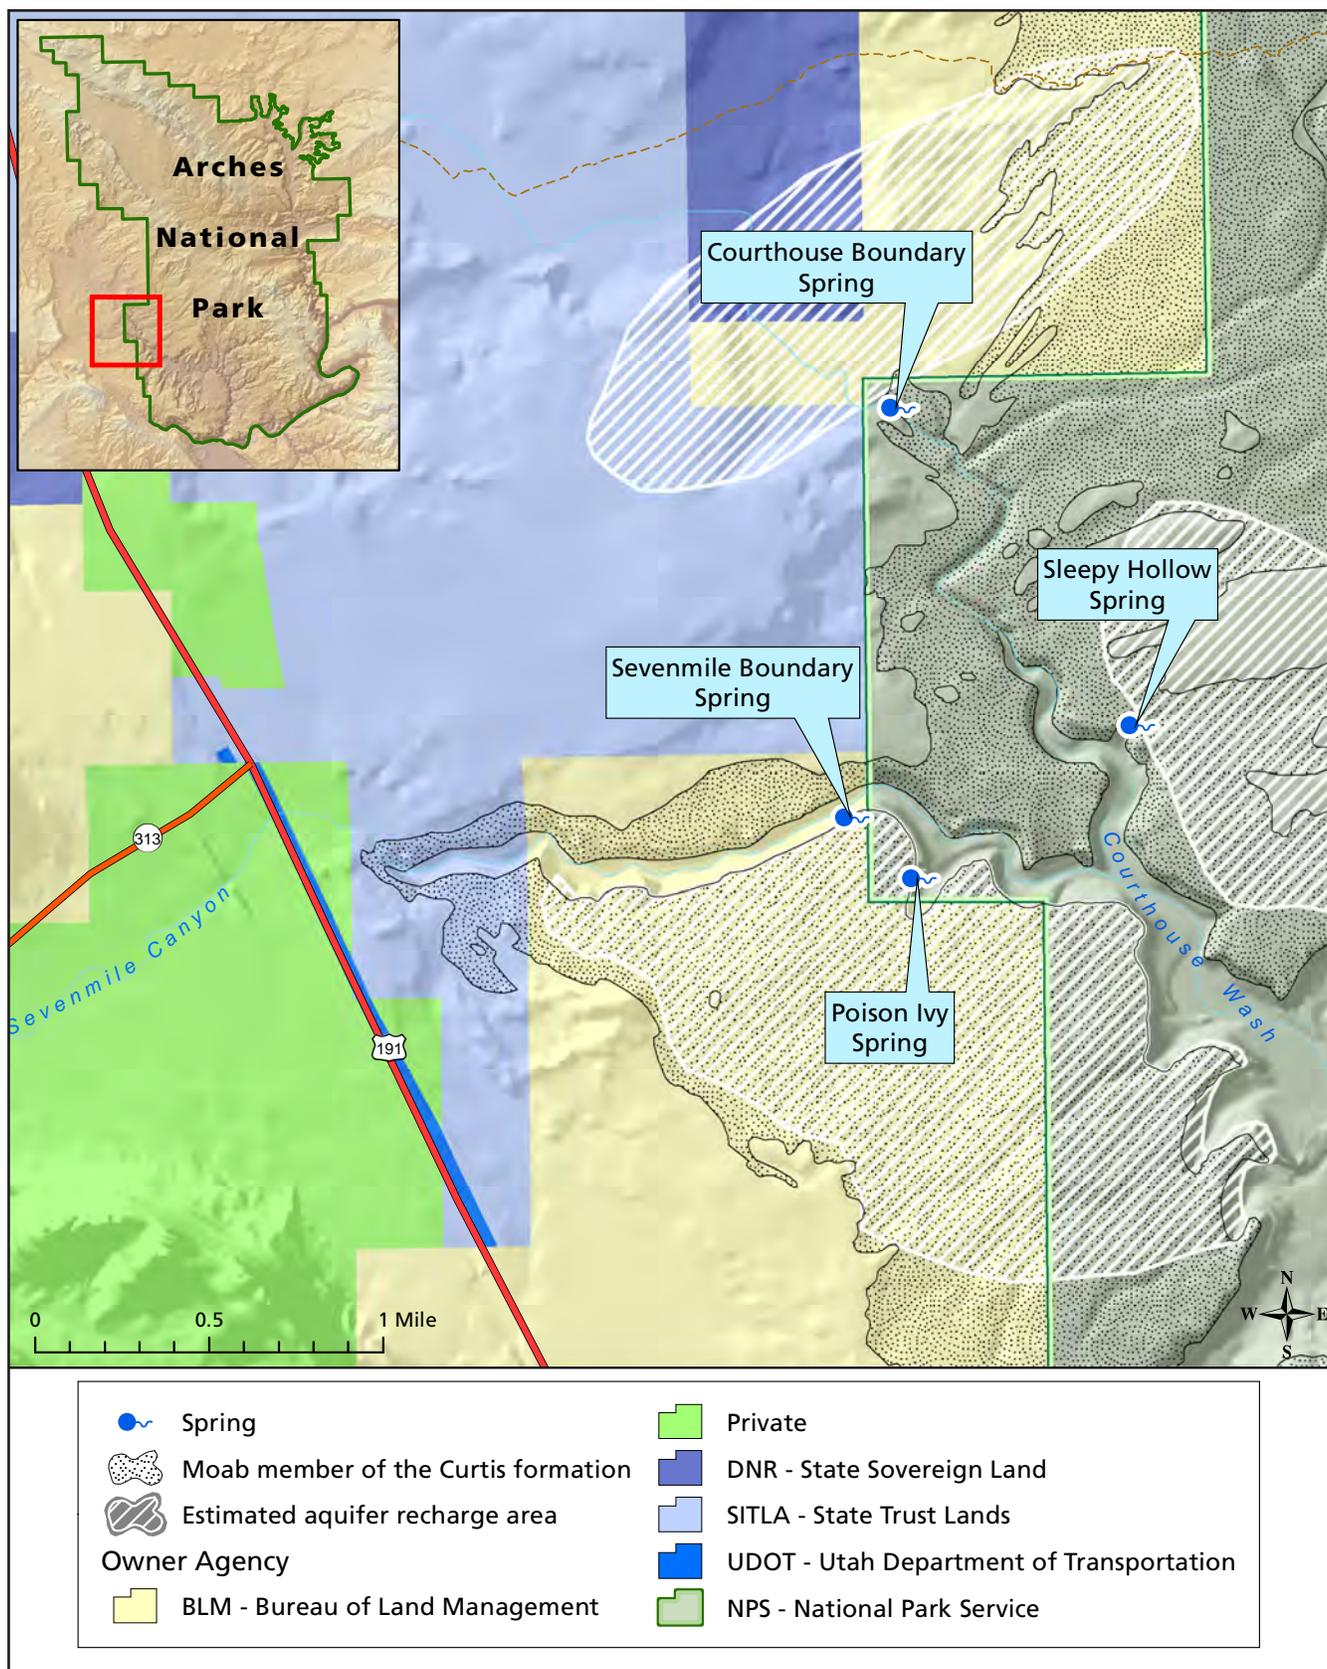
Figure 1-2. The four springs in and adjacent to Arches National Park selected for long-term flow monitoring. Springs are primarily recharged through local outcrops of the Moab Member of the Curtis Formation, some of which lie outside park boundaries. DNR = Department of Natural Resources; SITLA = School and Institutional Trust Lands Administration

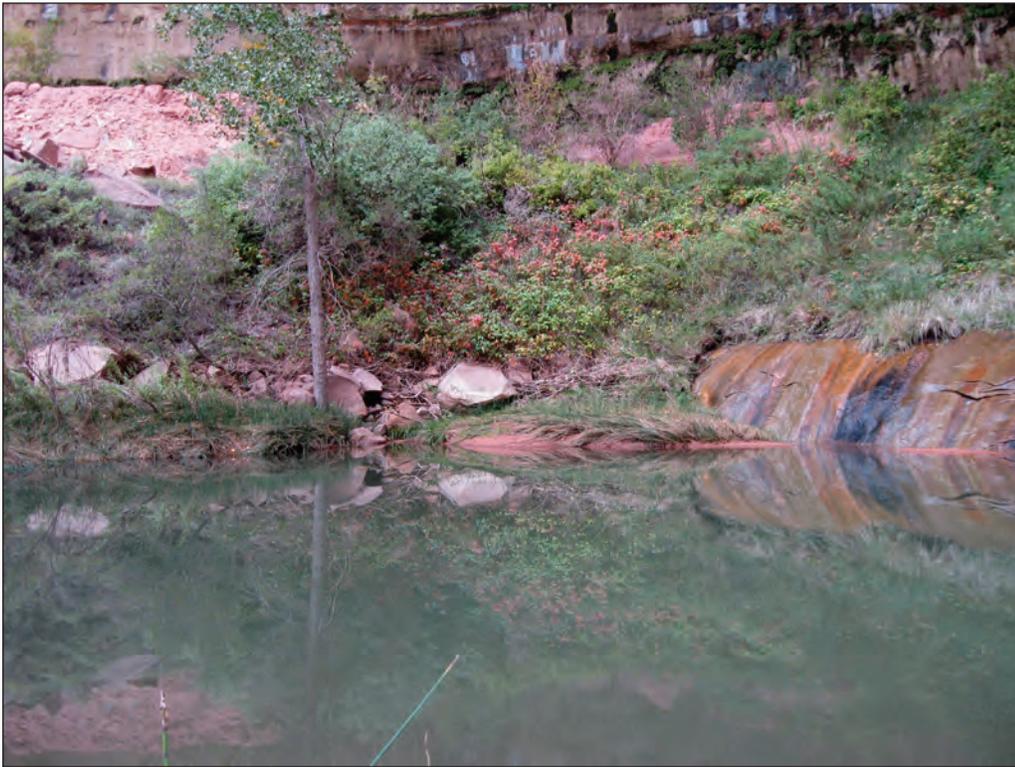
Figure 1-3. Sleepy Hollow Spring pool and lower part of backwall, October 2010.

Sleepy Hollow Spring is located in the back of a large alcove on the east side of Courthouse Wash Canyon, roughly 0.8 kilometers upstream of Courthouse's confluence with Sevenmile Canyon. Multi-tiered seeps emerge from near the base of the Moab Member along a hanging-garden backwall. A perennial pool, roughly 10 meters in diameter, lies at the base of the backwall (Figure 1-3). Some seeps may emerge under the waters of the pool. A single outflow channel carries surface flow from the large pool. Flow is measured within the outflow channel, 2–5 meters downstream of the large pool.

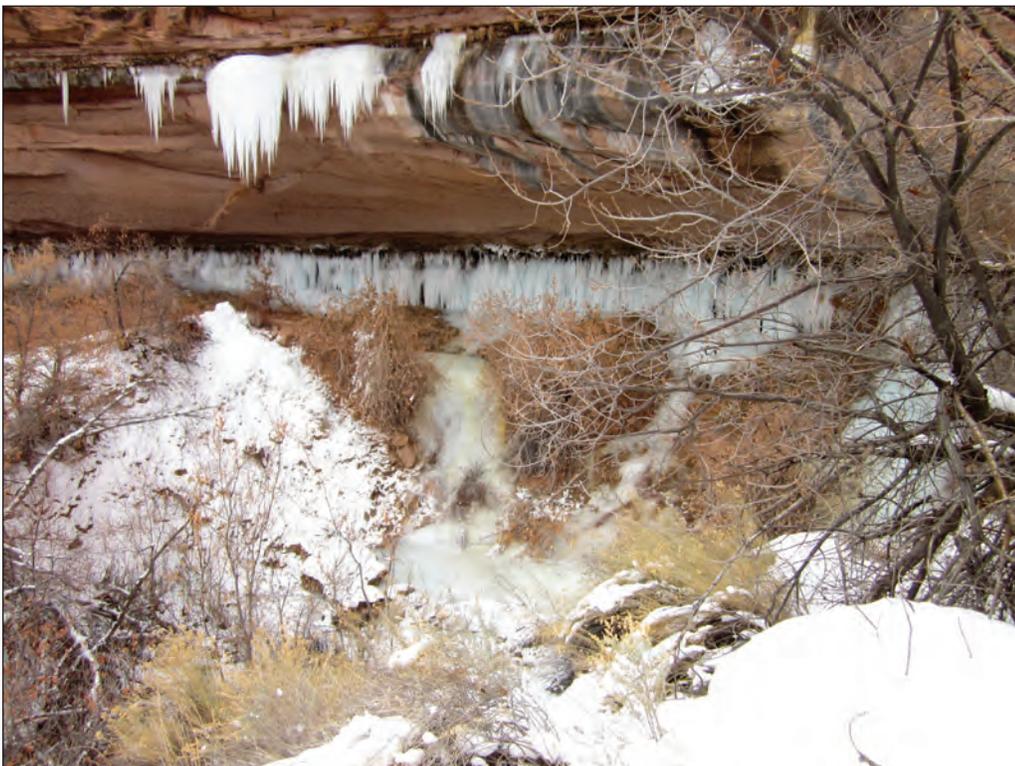
Figure 1-4. Sevenmile Boundary Spring seeplines and pool, January 2013.

Sevenmile Boundary Spring is located in a small, north-facing alcove on the south side of Sevenmile Canyon, just outside the park boundary on BLM land. It emerges as multiple seeps from several seep lines at and above the base of the Moab Member, along a hanging-garden backwall (Figure 1-4). A small pool or pools are present near the base of the wall and two small channels converge into one channel downslope of the pools. No obvious pouroff site exists at the top of the backwall, and in 14 years of monitoring, evidence of only a few small flood events has been observed in the stream channel. Flow is measured in the combined channel at a designated location roughly 15 meters downstream of the base of the wall. Hanging-garden and riparian vegetation are diverse and dense at this site, and liverworts grow on the colluvial boulders at the base of the wall.

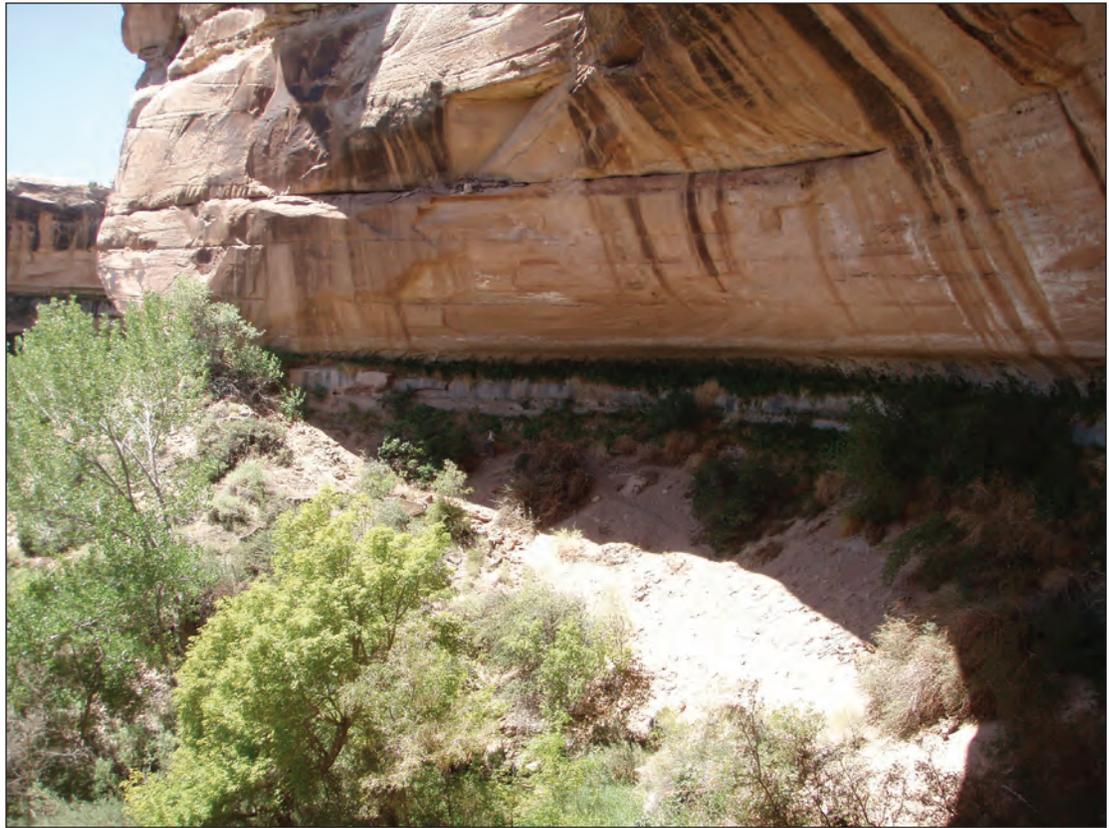
Figure 1-5. Poison Ivy Spring seep lines and colluvial slope, June 2010. The trees in the foreground line a channel where springflow coalesces.

Poison Ivy Spring is located within a short side canyon on the southwest side of Sevenmile Canyon, roughly one kilometer upstream of its confluence with Courthouse Wash and approximately 1,200 feet aerially from Sevenmile Boundary Spring. Measurements capture outflow from the largest alcove within this side canyon, on the west side of the side canyon. Like Sevenmile Boundary Spring, Poison Ivy Spring emerges from multiple seeps from several locations at and above the base of the Moab Member, along a hanging-garden backwall (Figure 1-5). At this site, a colluvial (detritus) slope lies at the base of much of the backwall. There are a few pools at the base of the slope, and a small, defined channel forms downslope of the pools. There is no significant pouroff site at the top of the backwall, and the only evidence of flood events observed has been some leaves and organic detritus accumulation on several occasions. Flow is measured in a merged channel roughly 30 meters downslope of the

base of the backwall/colluvial slope. Riparian and spring vegetation is dense in the measurement area, including multiple tree species and a dense undergrowth of horsetail (*Equisetum hyemale*) and poison ivy (*Toxicodendron rydbergii*).

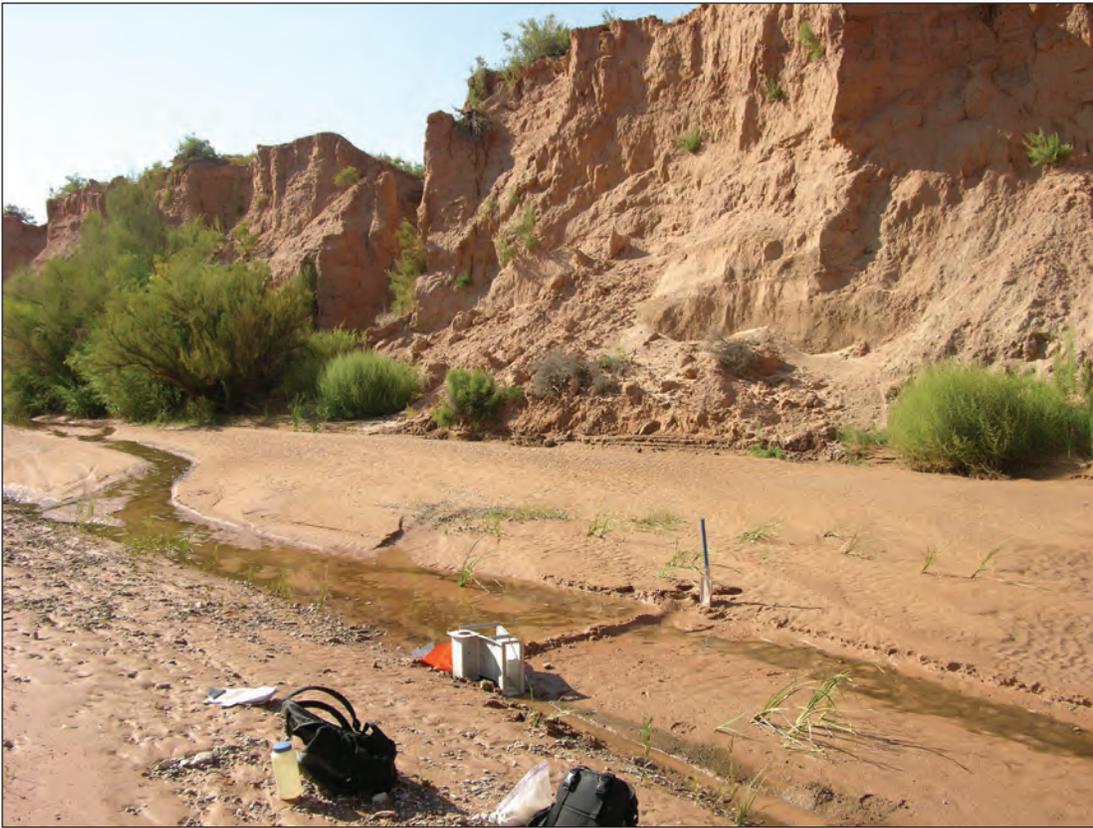
Figure 1-6. Alluvial setting of Courthouse Boundary Spring, September 2007.

Courthouse Boundary Spring has a different setting and source than the other three monitored springs. It emerges from the bottom of Courthouse Wash, in an open area several hundred meters upstream of where the wash enters Courthouse Wash Canyon (Figure 1-6). The spring emergence area appears to be at least 75 meters long along the wash bottom. The upper end of this reach is defined by a perennial pool bounded on its upstream edge by exposed, sloping bedrock, and a smaller pool just one or two meters upstream, on the bedrock surface. Stratigraphically, the springs emerge not from the bottom of the Moab Member, but from joints and cross-bed surfaces near the top of the unit (Hurlow and Bishop 2003). The layers of the

overlying Summerville and Morrison formations can be seen in the low hills to the west of the site. Shifting alluvial sediments cover the wide wash bottom, and the retreating edge of an alluvial terrace forms a vertical cliff roughly ten meters high along the eastern margin of the wash in this area.

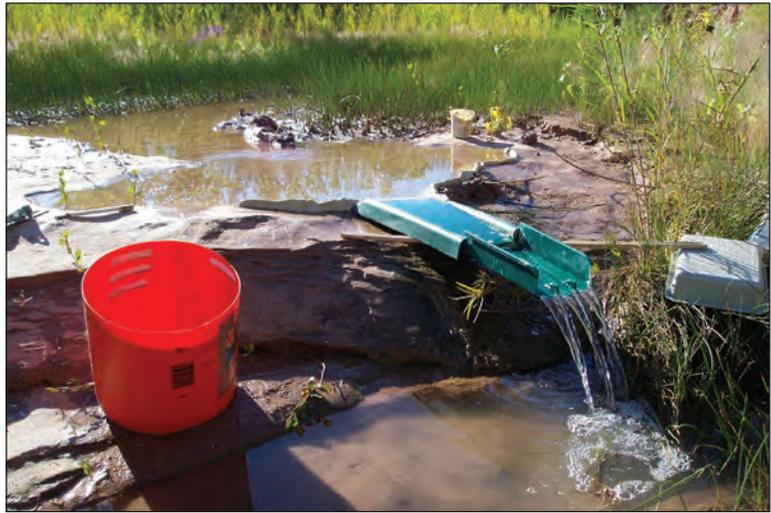
Figure 2-1. Original flow-measurement location at Courthouse Boundary Spring, showing a bedrock ledge subsequently buried in flood events.

The measurement-site location and measurement method at Courthouse Boundary Spring changed after a flood event in October 2005 deposited sediments that buried all exposed bedrock at the spring. From November 2005 through November 2009, a portable Parshall flume and associated staff gage were used to measure springflow at this site (see Figure 1-6). The measurement-site location and measurement method were again changed after surface flow decreased due to additional sediment deposition at the measurement site, and a timed filling of a plastic bag was used to measure flow in 2010 and 2011, until measurements were discontinued in fall 2011.

From 2001 until October 2005, a rock shelf exposed in the channel 25 meters downstream from the source area concentrated surface flow and allowed the flow to be easily measured using a pipe, bucket, and stopwatch. Flood events after October 2005 have deposited enough sediment in the channel (and continue to rework existing sediments) to completely bury the rock shelf, eliminating the measurement site used from 2001 to 2005. Since October 2005, additional sediment deposition in the Courthouse Wash stream channel has led to a braided channel where much of the flow consists of subsurface flow (flowing through the deposited sediments), and it has become impractical to attempt to concentrate and measure surface flow. Because of these issues, monitoring at this site was suspended in 2011. There are no plans to resume monitoring here unless a stable flow monitoring location becomes available.

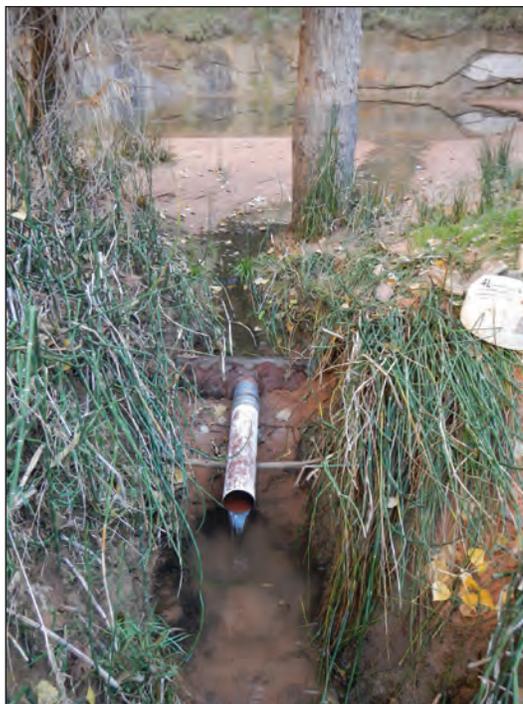
Figure 2-2. Example of constructed weir plate and installation at Sleepy Hollow Spring, October 2014.

plate steel. A hole three inches in diameter was cut from the center of the plate and a length of steel pipe three inches in diameter was welded into the hole (Figure 2-2).

To block the flow, the weir plate is hammered into the channel bottom and streambanks perpendicular to the flow path, and any leaks around the perimeter of the plate are blocked with soil found onsite. A staff gage is installed in the pool upstream of the weir plate and the water level in the pool is allowed to stabilize before a flow measurement is made. Springflow measurements are made by placing a

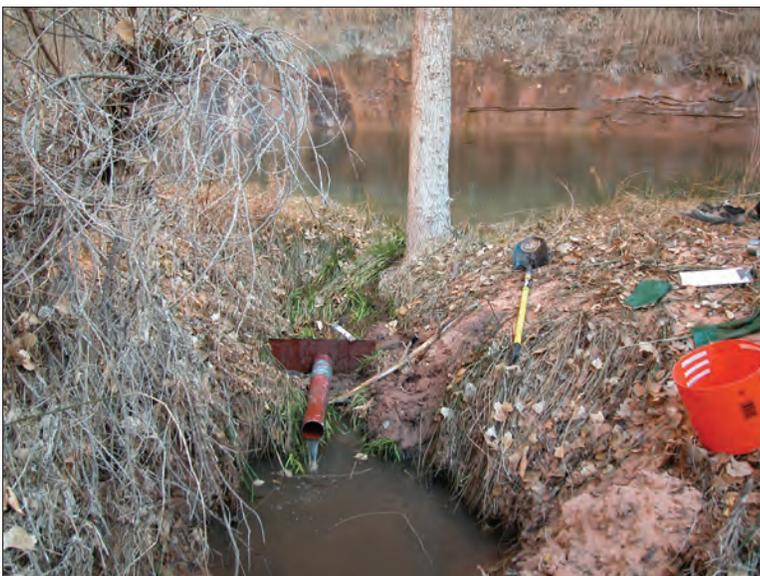
Figure 2-3. Sleepy Hollow Spring flow-measurement location and weir, December 2002.

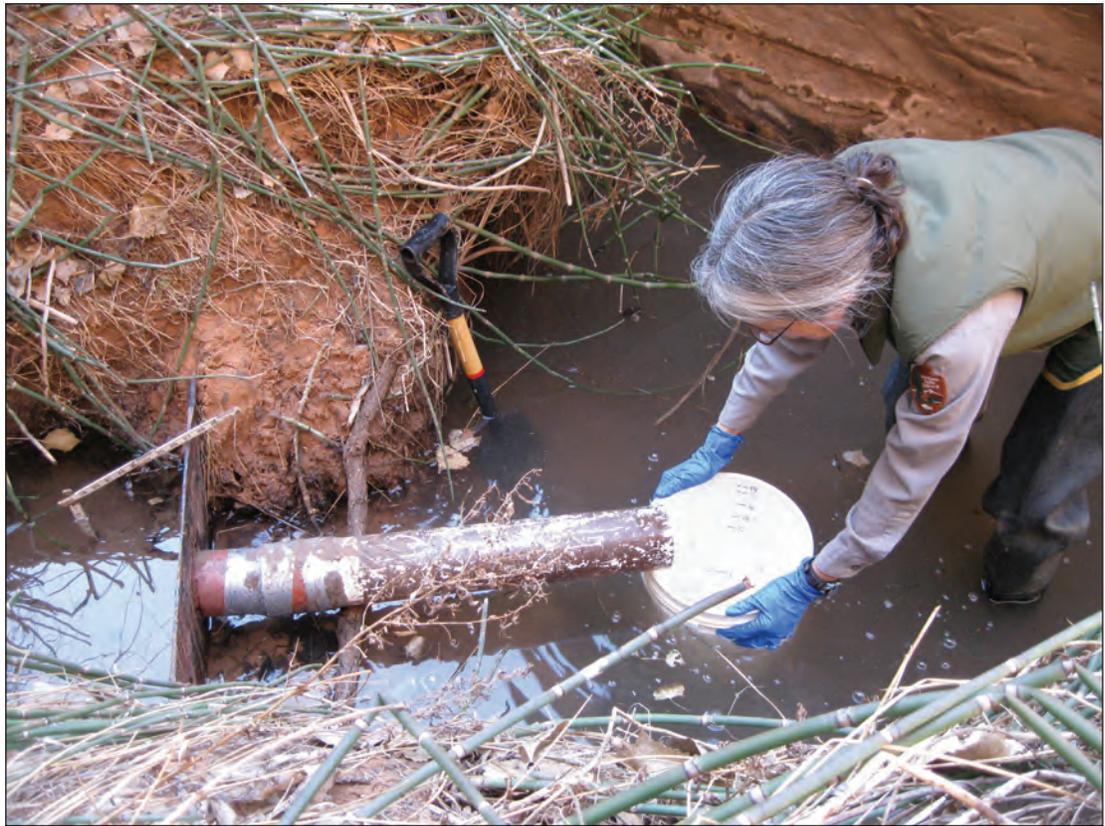
Figure 2-4. Flow measurement location and method at Sleepy Hollow Spring from November 2005 to early 2014, approximately 5 m downstream from original location.

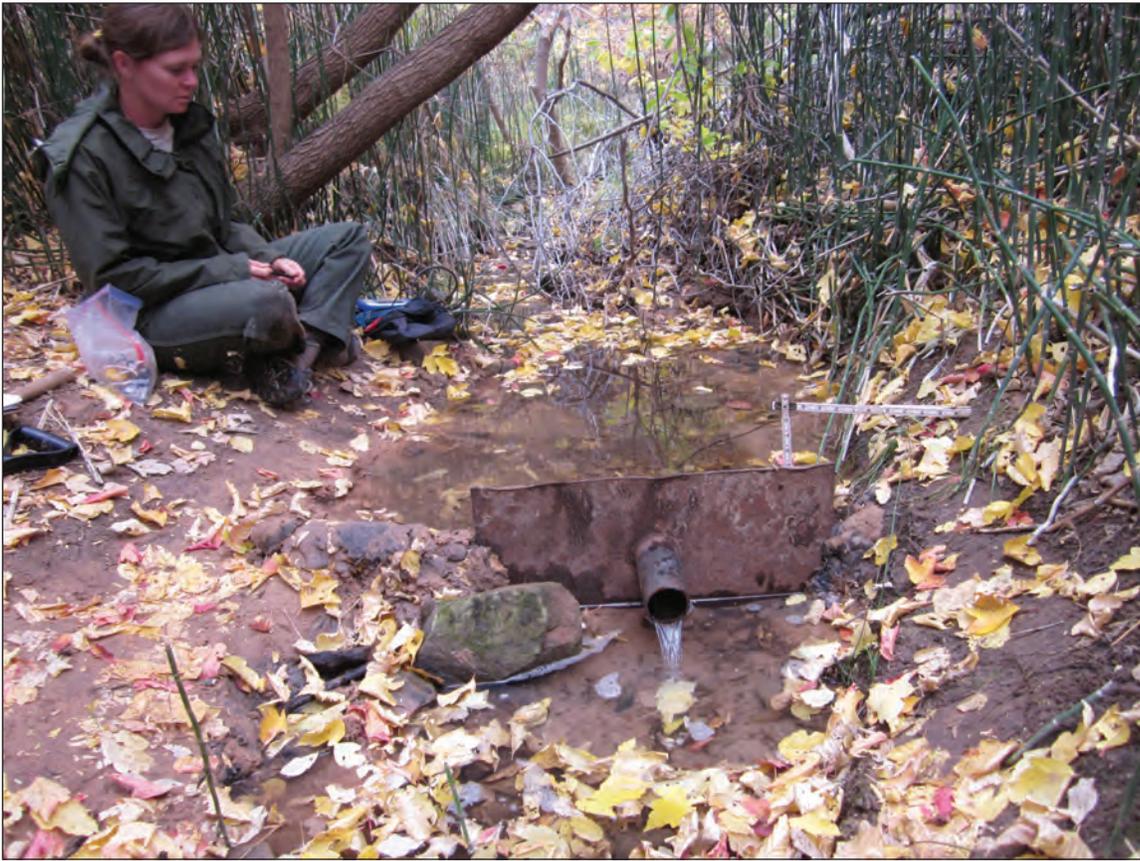
Figure 2-5. Flow measurement location and weir placement at Sevenmile Boundary Spring, October 2012.

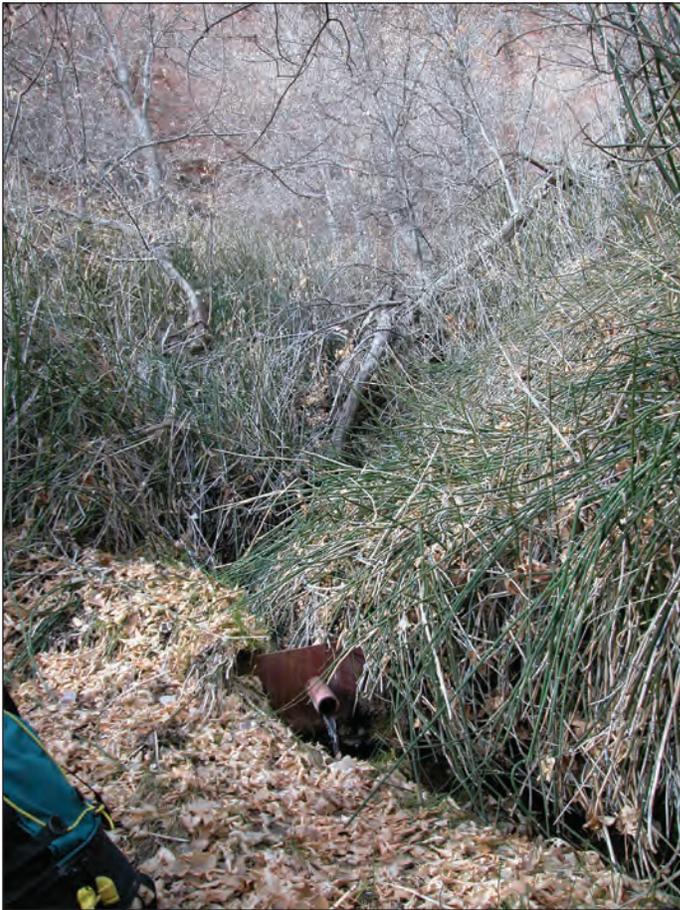
Figure 2-6. Flow measurement location and weir placement at Poison Ivy Spring, December 2002.

At the Poison Ivy Spring measurement site, flow was measured about 30 m downslope of the colluvial slope where the water coalesces into a flowing channel (Figure 2-6). Initially, the weir plate was left in place for several years, rather than being installed and then removed for each monthly measurement, because of the amount of poison ivy at the site. Leaving the weir in place caused a mossy, spongy channel bottom substrate to form behind the weir, and in August 2006, some water was flowing through this substrate under the weir. We moved the weir upstream 0.7 meters in September 2006, and continued capturing water in a four-liter bucket, while continually monitoring the situation.

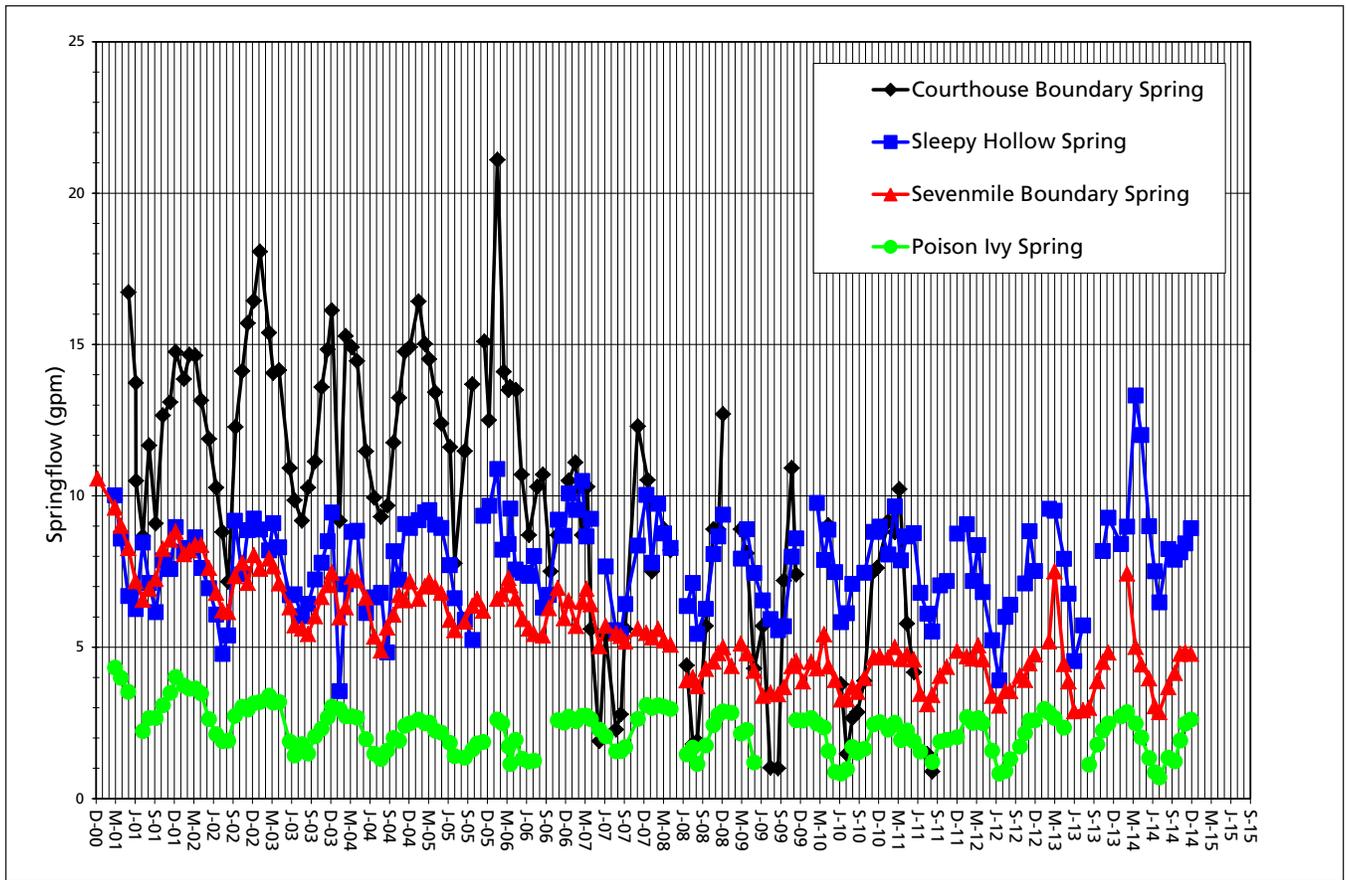
Figure 3-1. Springflow data for four springs included in the Courthouse Wash–Sevenmile Canyon springflow monitoring project, in and adjacent to Arches National Park, December 2000–December 2014. Month and year are indicated on x-axis; flow in gallons per minute (gpm) is indicated on y-axis.

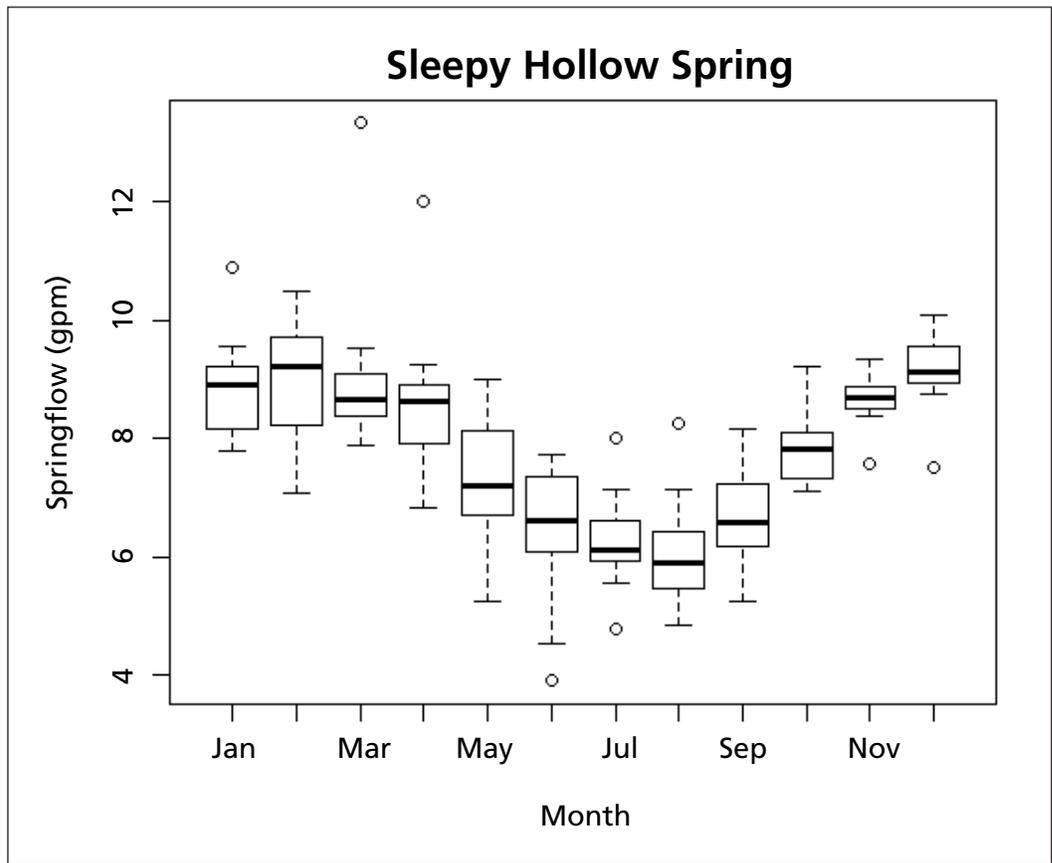
Figure 3-2. Seasonal variation in flow at Sleepy Hollow Spring, 2001–2014.

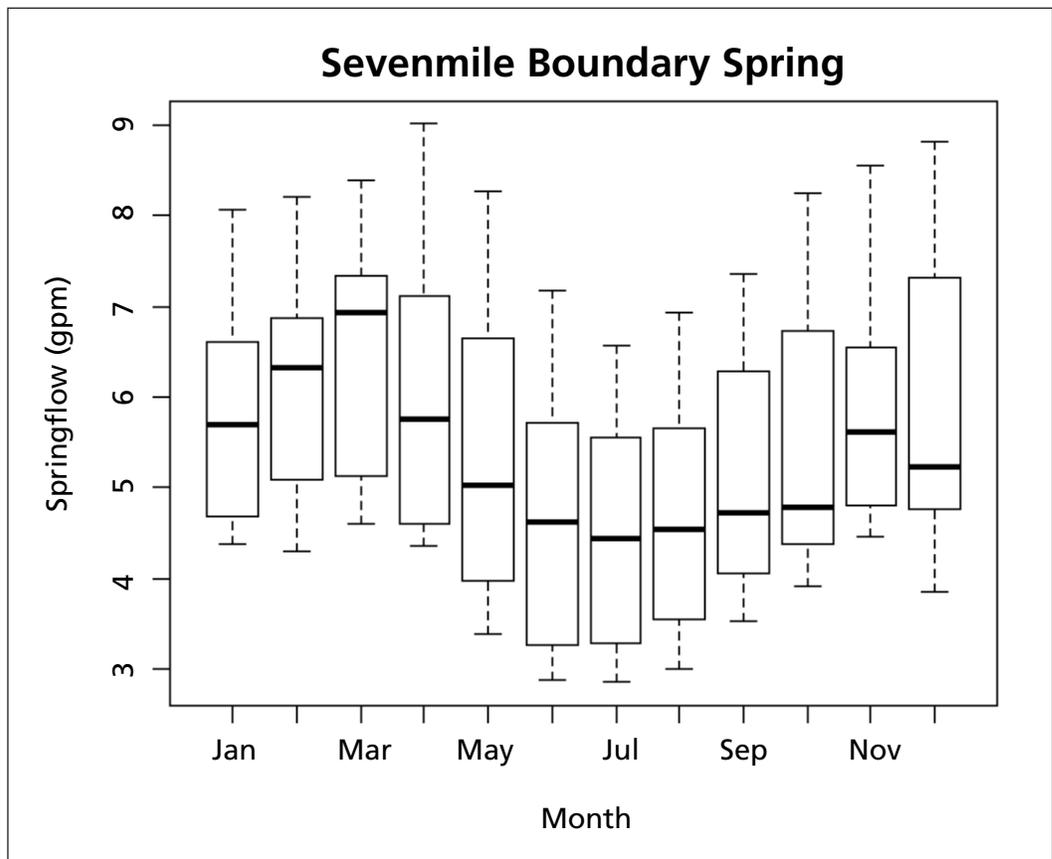
Figure 3-3. Seasonal variation in flow at Sevenmile Boundary Spring, 2001–2014.

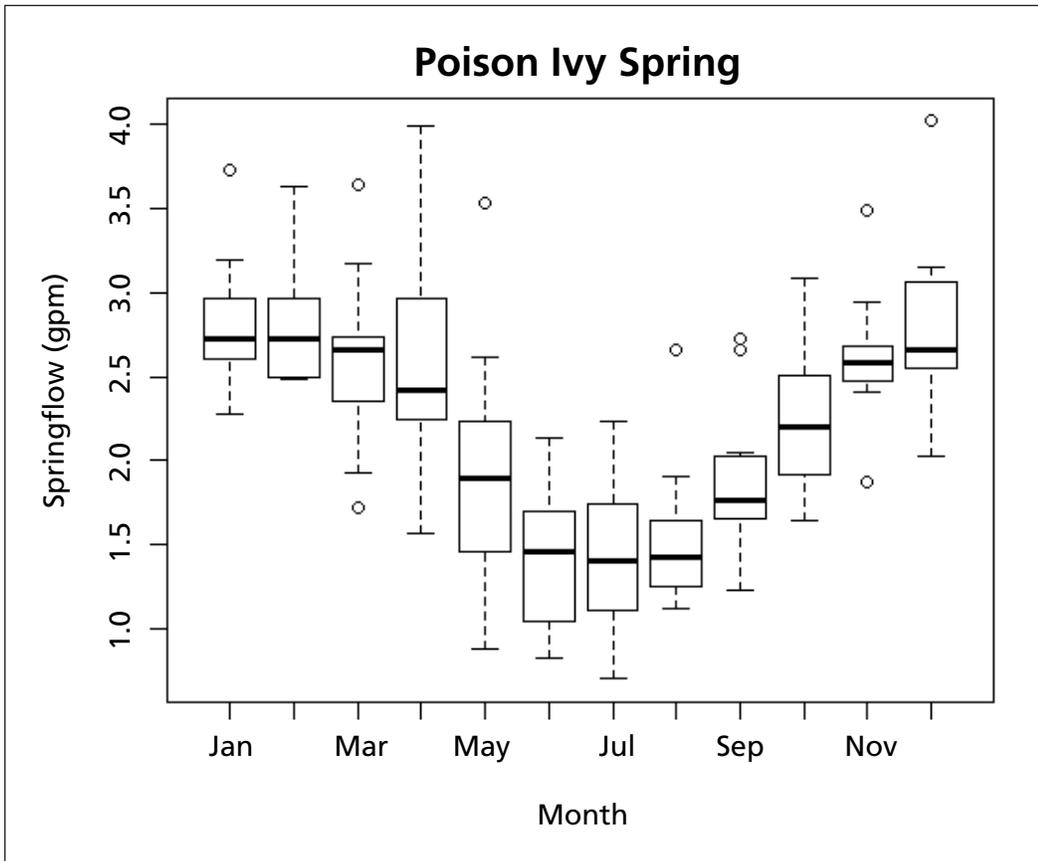
Figure 3-4. Seasonal variation in flow at Poison Ivy Spring, 2001–2014.

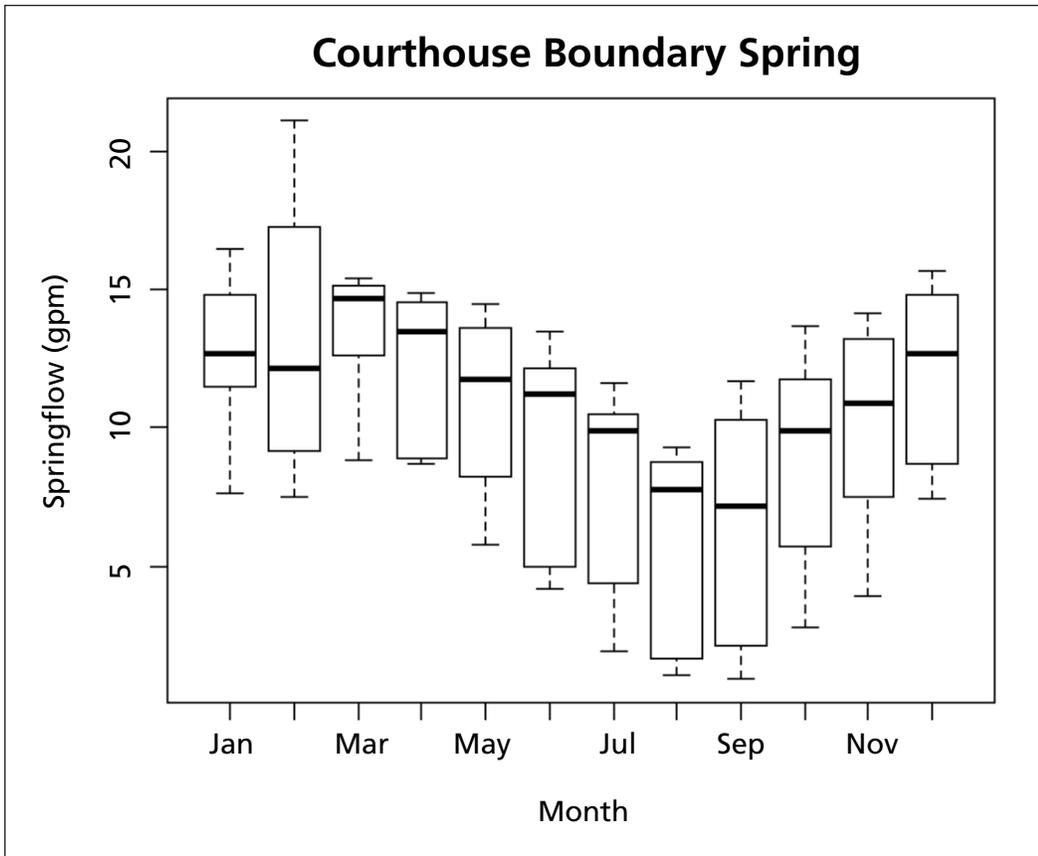
Figure 3-5. Seasonal variation in flow at Courthouse Boundary Spring, 2001–2011.

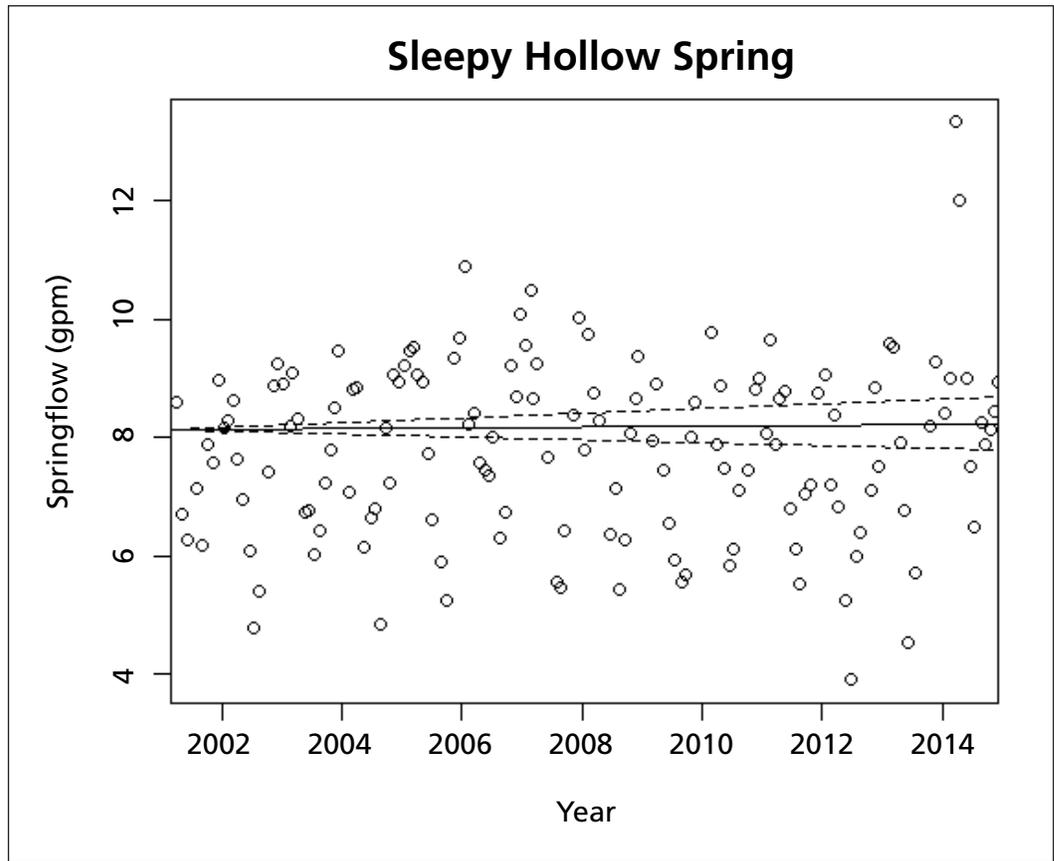
Figure 3-6. Sen slope with 95% confidence intervals shows no significant trend over time at Sleepy Hollow Spring.

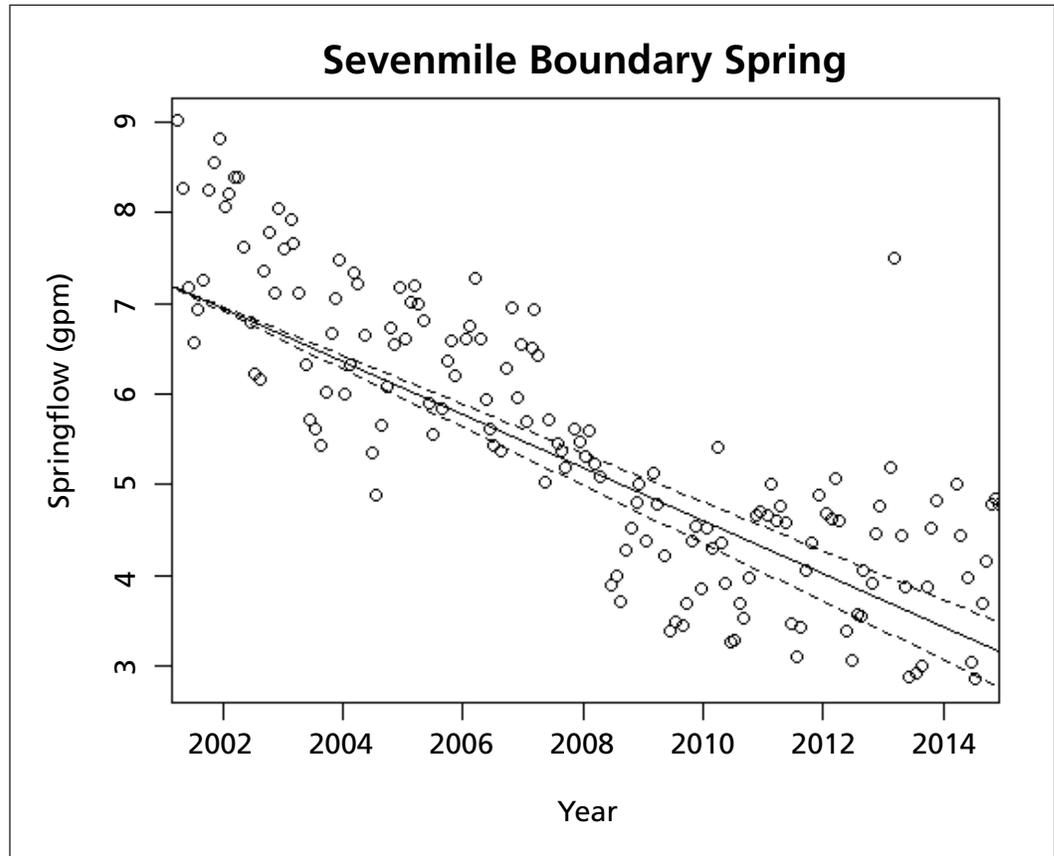
Figure 3-7. Sen slope with 95% confidence intervals shows a significant downward trend over time at Sevenmile Boundary Spring.

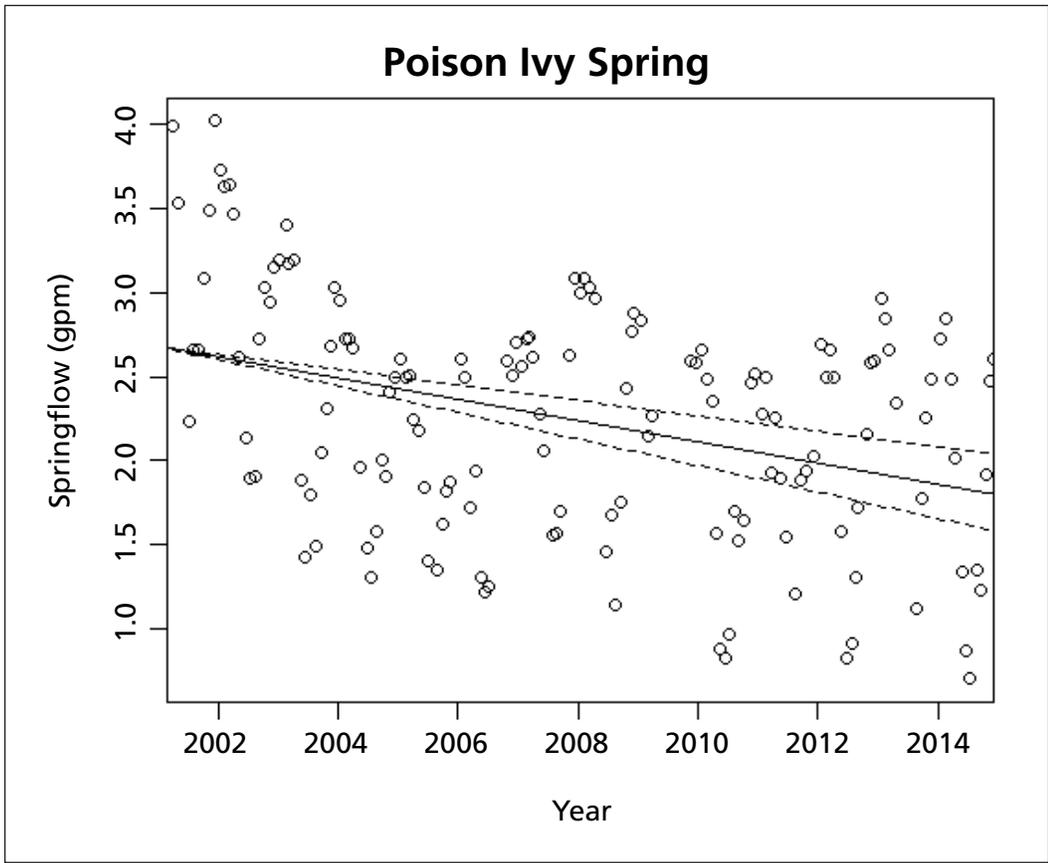
Figure 3-8. Sen slope with 95% confidence intervals shows a significant downward trend over time at Poison Ivy Spring.

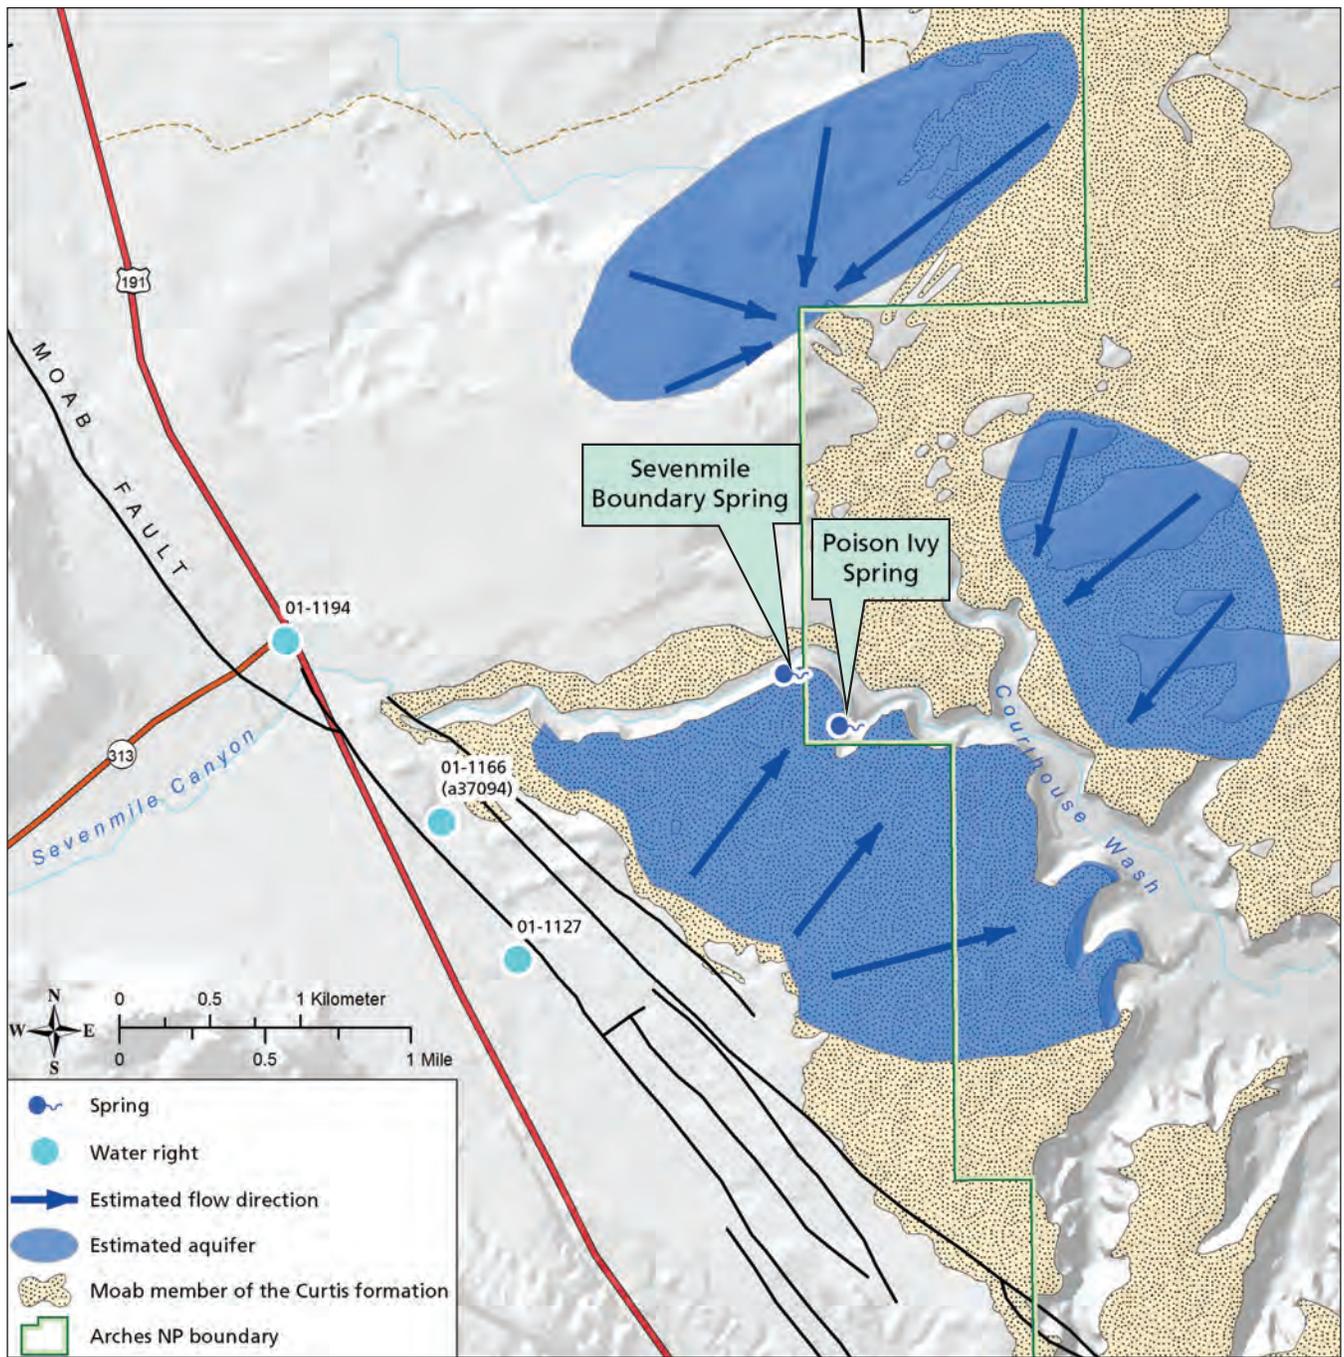
Figure 3-9. Existing water rights near Sevenmile Boundary Spring and Poison Ivy Spring relative to the Moab Member of the Curtis Formation and mapped faults. Estimated aquifers and flow directions taken from Hurlow and Bishop (2003).

Water Right Number 01-1194 is for a water well located east of the Moab Fault, west of State Highway 191, and approximately 700 feet north of the Sevenmile Canyon stream channel. As required by the conditions of approval for this water right, the well is completed in and draws its water from the Navajo Sandstone aquifer. The Moab Member of the Curtis Formation is sealed off from other rock units during the drilling process. As the Navajo Sandstone is separated from the Moab Member of the Curtis Formation by the Dewey Bridge Member of the Carmel Formation (Figure 3-10), a confining rock unit, this well should not affect the spring-flow of Sevenmile Boundary Spring and Poison Ivy Spring.

Water Right Number 01-1166, Change Application a37094, is for a water well located east of the Moab Fault, east of State Highway 191, and south of Sevenmile Canyon. There is no documentation in the Utah Division of Water Rights online database that a well has been drilled at this location to date. As required by the conditions of approval for this water right, any well would be completed in and draw its water from the Navajo Sandstone aquifer. The Moab Member of the Curtis Formation would be sealed off from other rock units during the drilling process. As the Navajo Sandstone is separated from the Moab Member of the Curtis Formation by the Dewey Bridge Member of the Carmel Formation, a confining rock unit, this well should not affect the springflow of Sevenmile Boundary Spring and Poison Ivy Spring.
