Fourteen Years of Springflow Data at Arches National Park

Natural Resource Report NPS/NCPN/NRR—2015/1018

September 2015

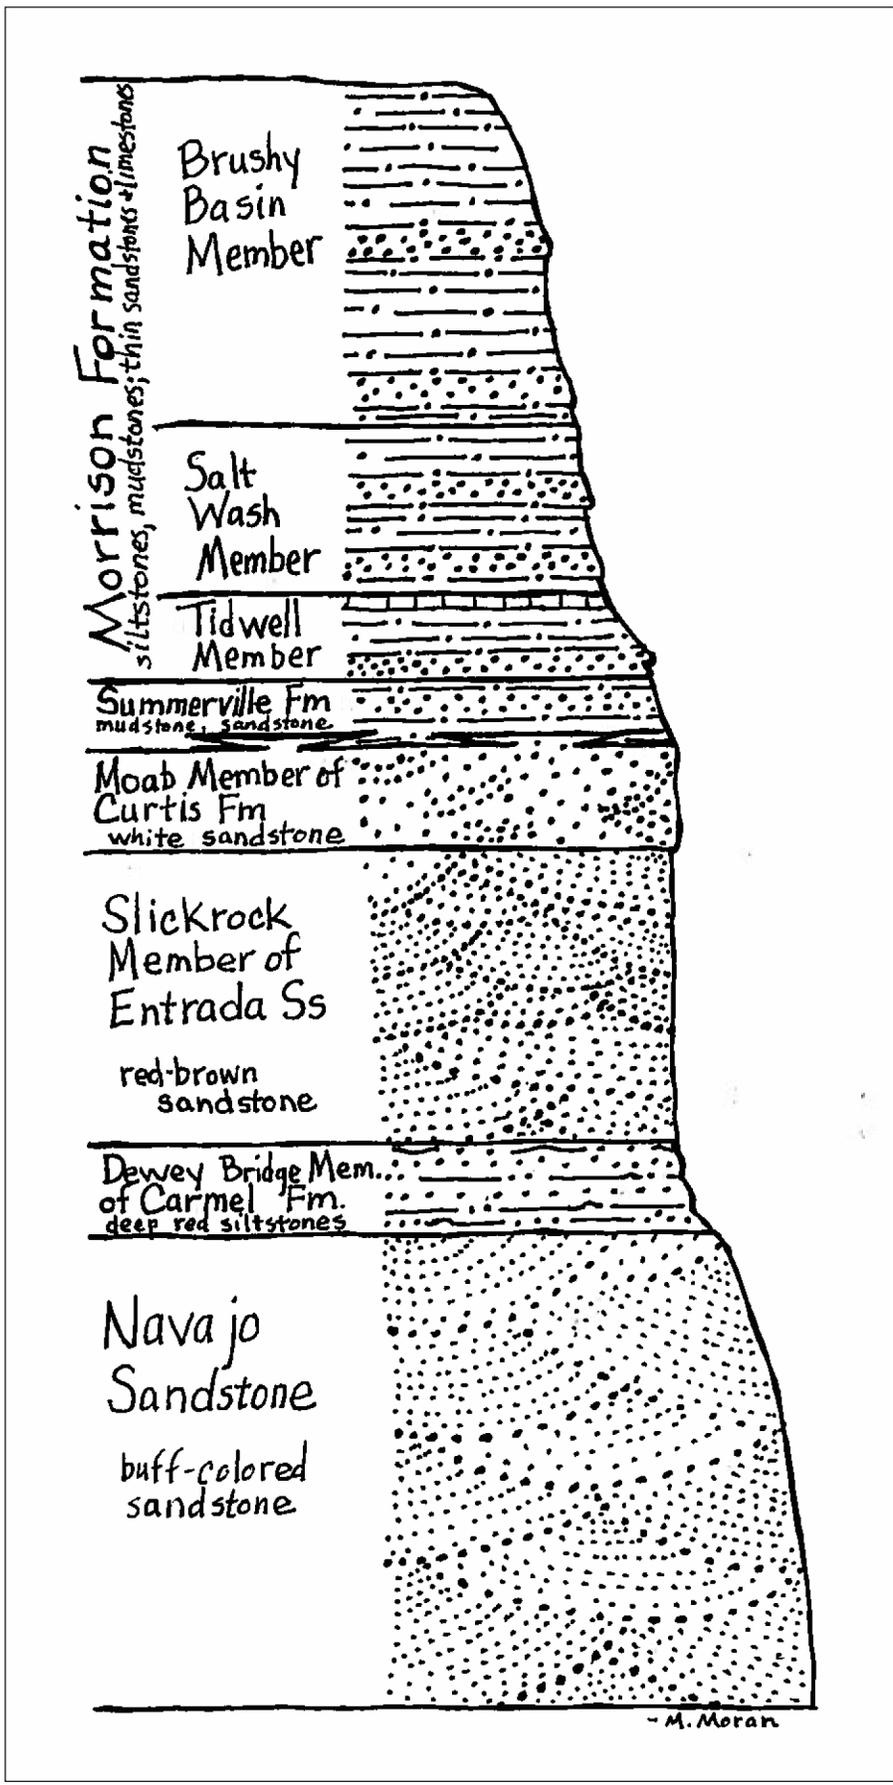
Figure 3-10. Stratigraphic section of the dominant rocks of Arches National Park. These rocks were deposited in the middle to upper Jurassic Period. The springs of Arches National Park are fed from an aquifer in the Moab Member of the Curtis Formation, and emerge from the lower part of this unit. The Navajo Sandstone holds a deeper, regional aquifer.

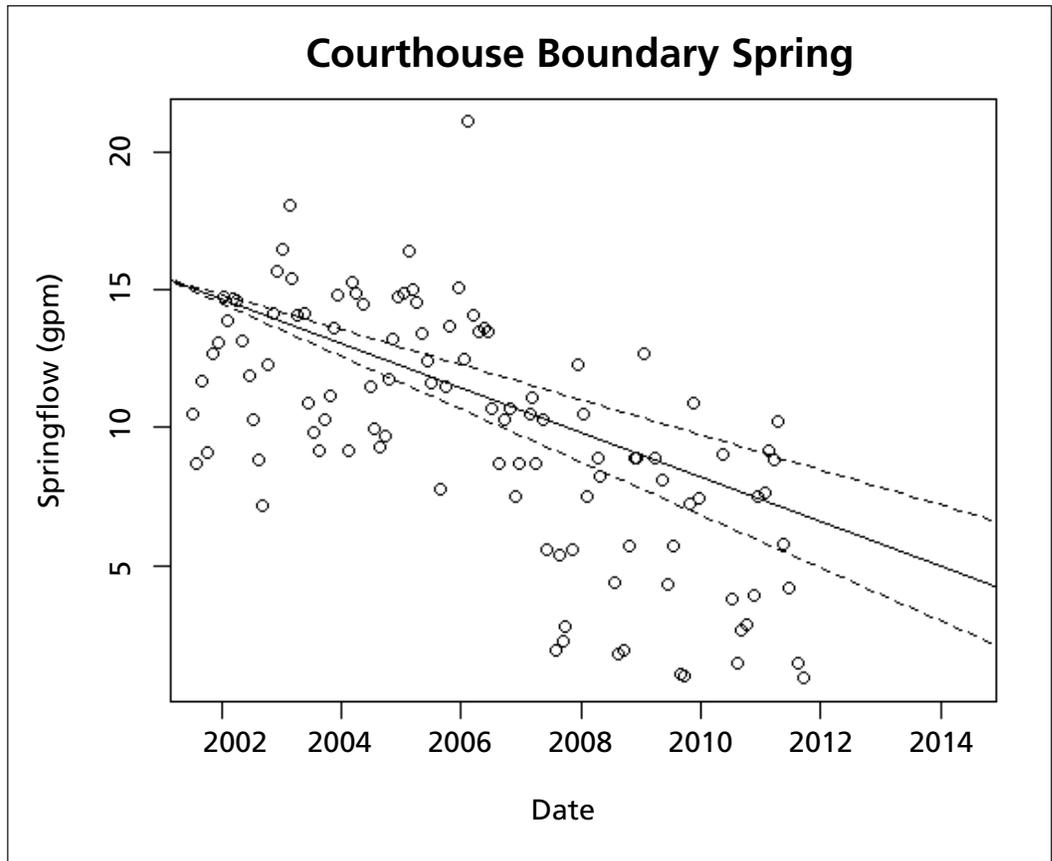
Figure 3-11. Sen slope with 95% confidence intervals shows a significant downward trend over time at Courthouse Boundary Spring.
