Streams Monitoring at Tumacácori National Historical Park

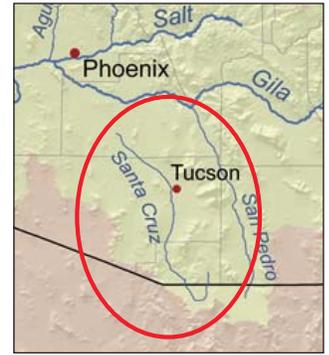
The Santa Cruz River flows through the park on its way north after curving south into Mexico not far from its headwaters in the U.S. (see map). Sometimes known as “the lessening stream,” as its flow has historically varied widely with changes in natural conditions and human use, the Santa Cruz at Tumacácori NHP has been bolstered in recent years by a steady flow of effluent (~13 million gallons/day [mgd]) from the Nogales International Wastewater Treatment Plant (NIWTP), located 10 miles upstream of the park. The flow at Tumacácori

The Santa Cruz is the only river to originate within the U.S., flow out of the country, and then re-enter it.

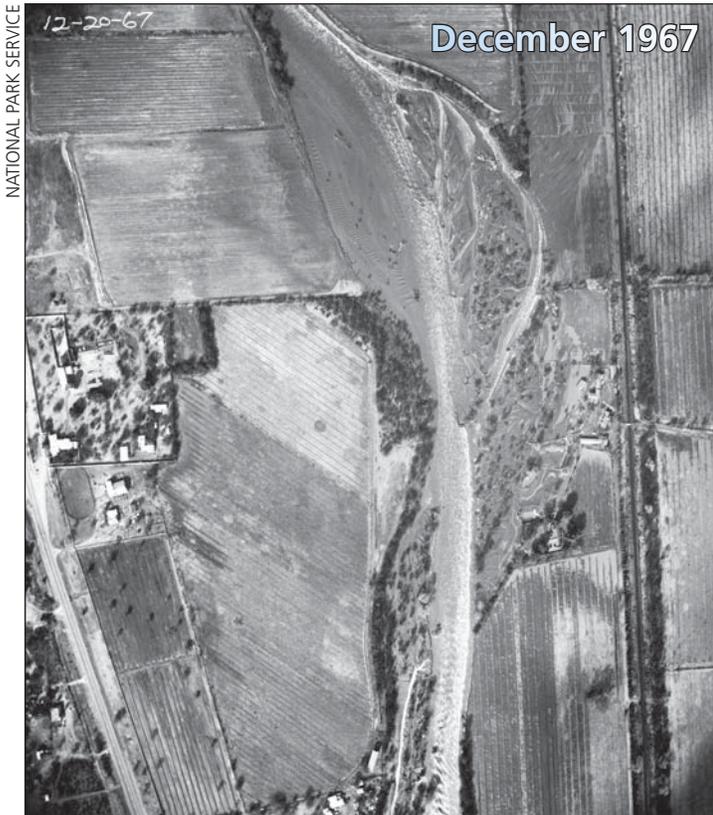
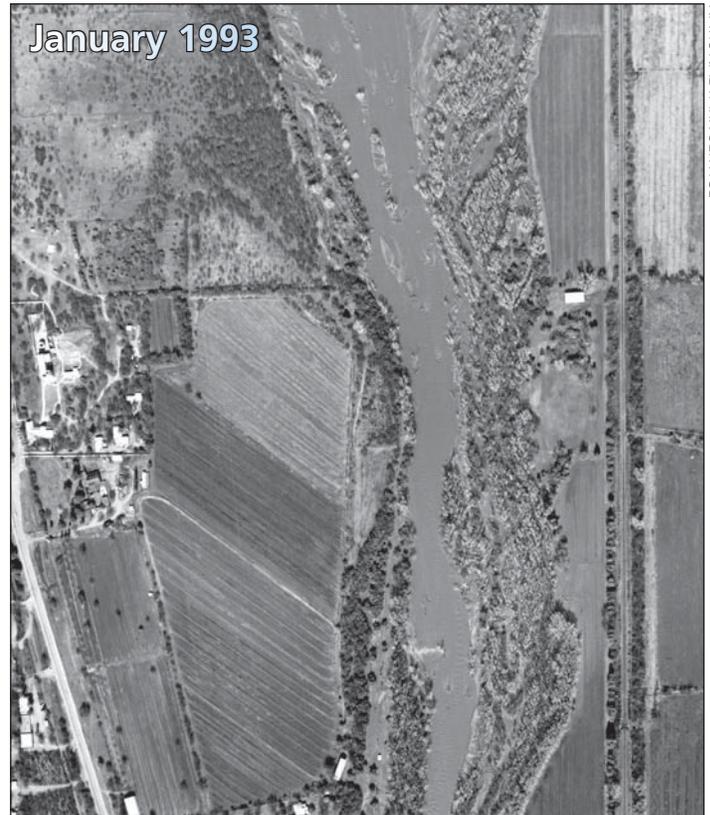
These aerial photos show the effects of the introduction of effluent flow on the riparian corridor of the Santa Cruz River. Barely visible from the air in 1967 (left), the river in 1993 (right) is banked on both sides by a ribbon of trees and other vegetation that has reclaimed some of Tumacácori National Historical Park's former agricultural fields.

Without the effluent flow, the Santa Cruz River through Tumacácori NHP would likely be an intermittent or ephemeral stream system, primarily responding to rain events in the watershed. Any reduction in effluent flow could result in both local and widespread impacts, including reduced aquatic habitat, loss of aquatic and riparian species, changes in channel morphology, and impacts to water quality and fish communities.
